## **CASE STUDY: HEAT LOAD REDUCTION**

**Marine Corps Base Camp Pendleton, California**

**Vado Del Rio Area 25**

**Animal Control Facility**

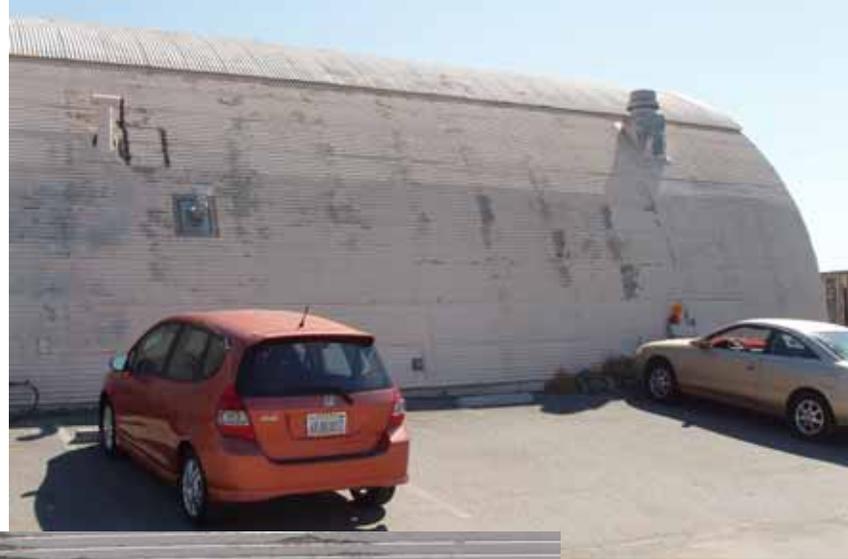
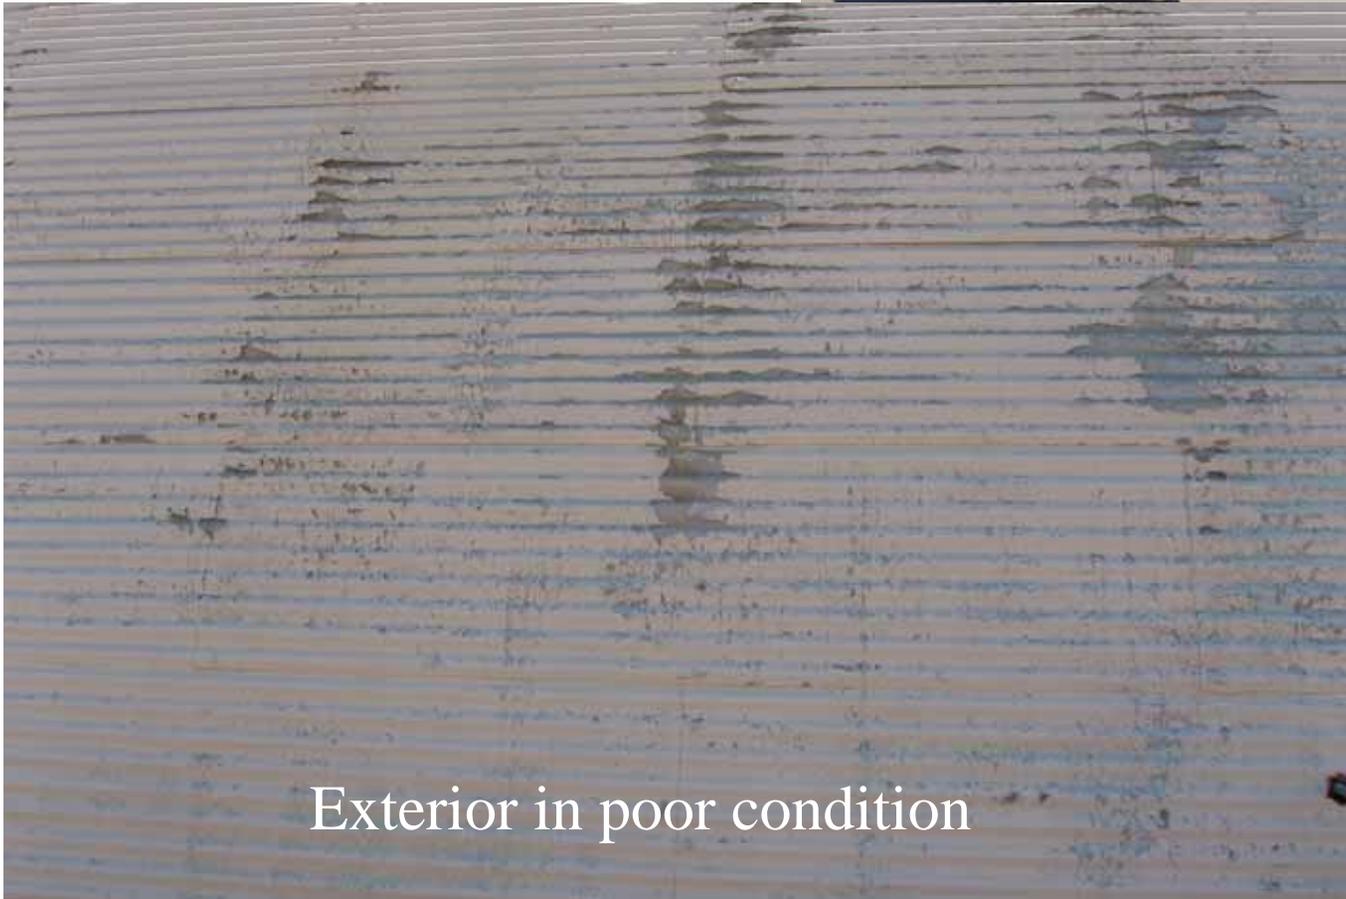
The exterior membrane had degraded and chipped/peeled off the structure exposing the various layers of paint buildup and bare metal.

Exterior in poor condition

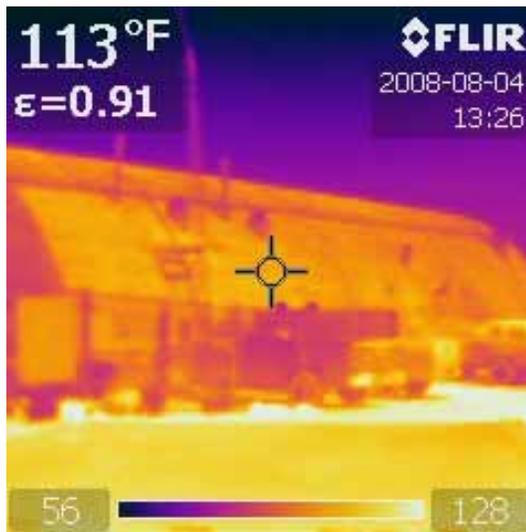
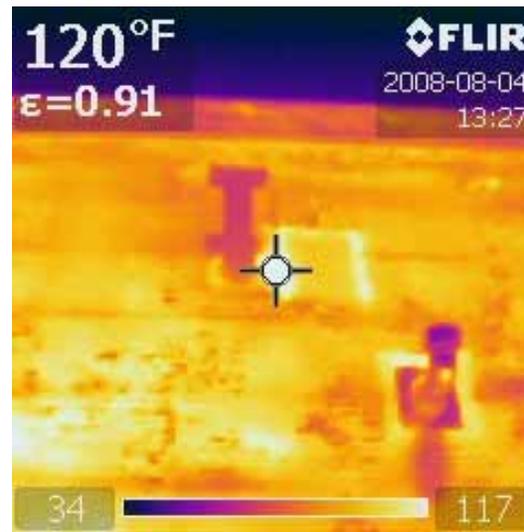
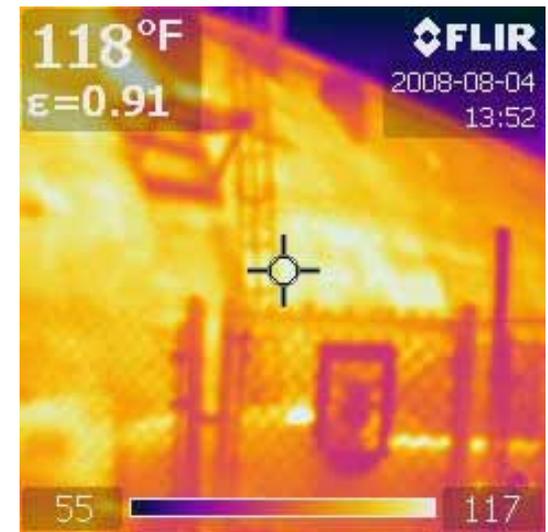
Needed to establish a baseline for heat load on structure  
Photos taken August 4, 2008

Bright, Sunny Sky with 84° F ambient air temperature

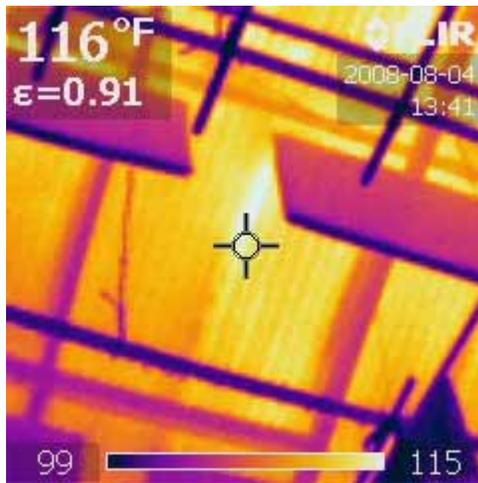
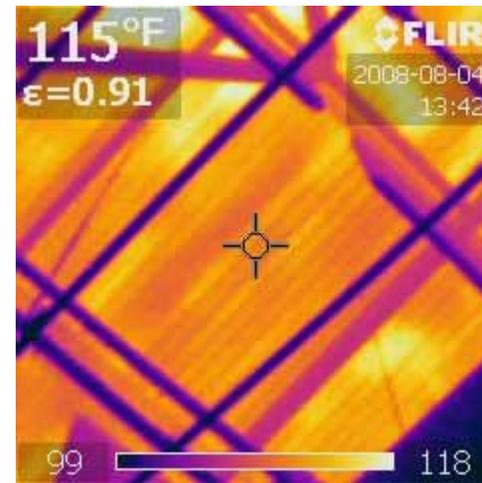
Different angles of the side walls

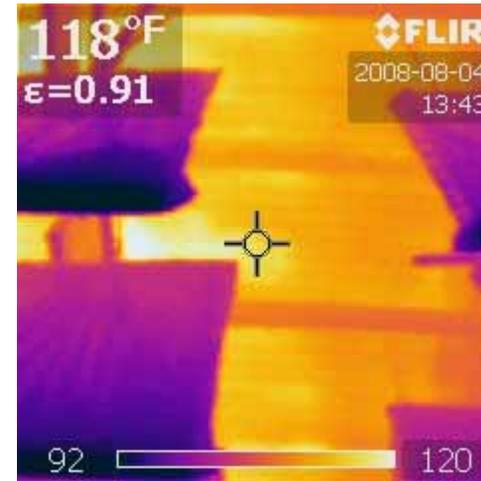
Greatest heat load on the building recorded here. 126° F maximum recorded temperature (Note temperature range on each photograph).

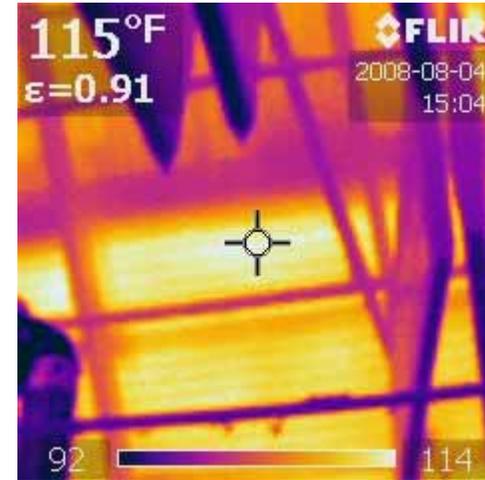
No significant increase of interior temperatures when compared to earlier photos taken at 1:40 PM.

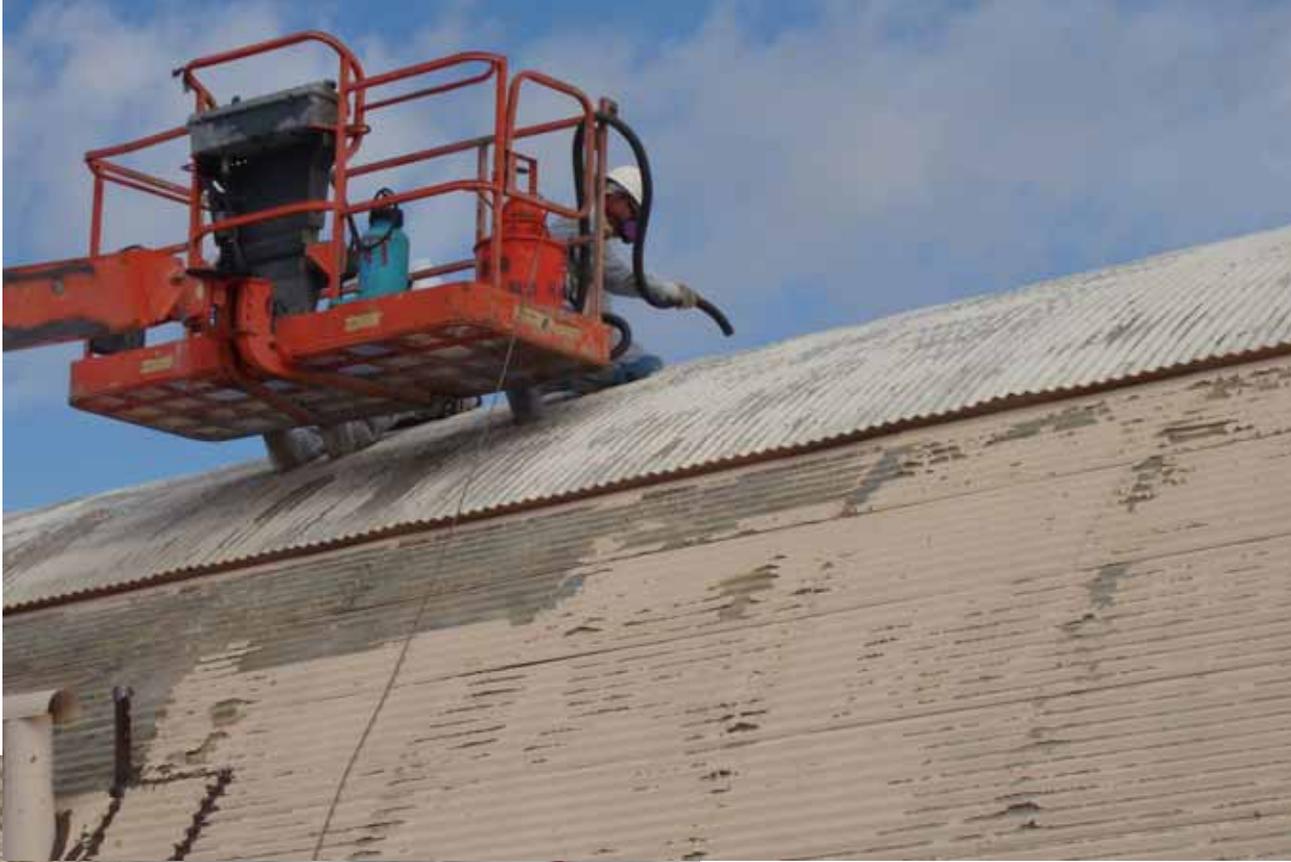
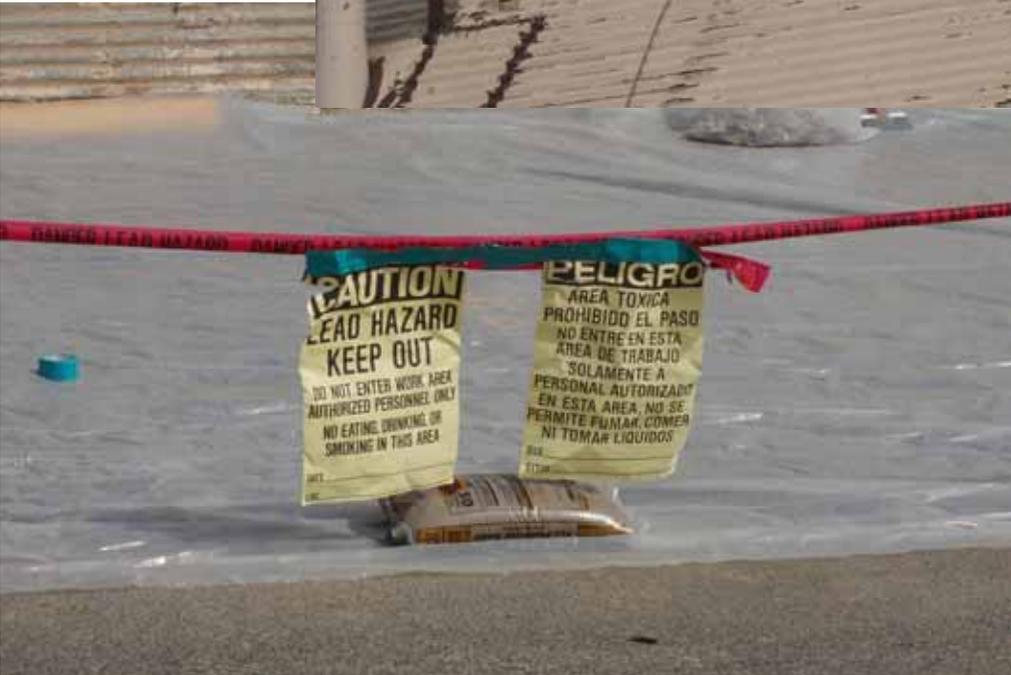
- There was suspicion that some of the existing layers of paint may be lead-based.
- Samples of the paint were tested and confirmed to contain lead.
- It therefore became necessary to remove the lead paint following approved environmental regulations and procedures.

Vacuum system used to collect lead chips and dust as they were removed from the structure and then shipped to disposal.

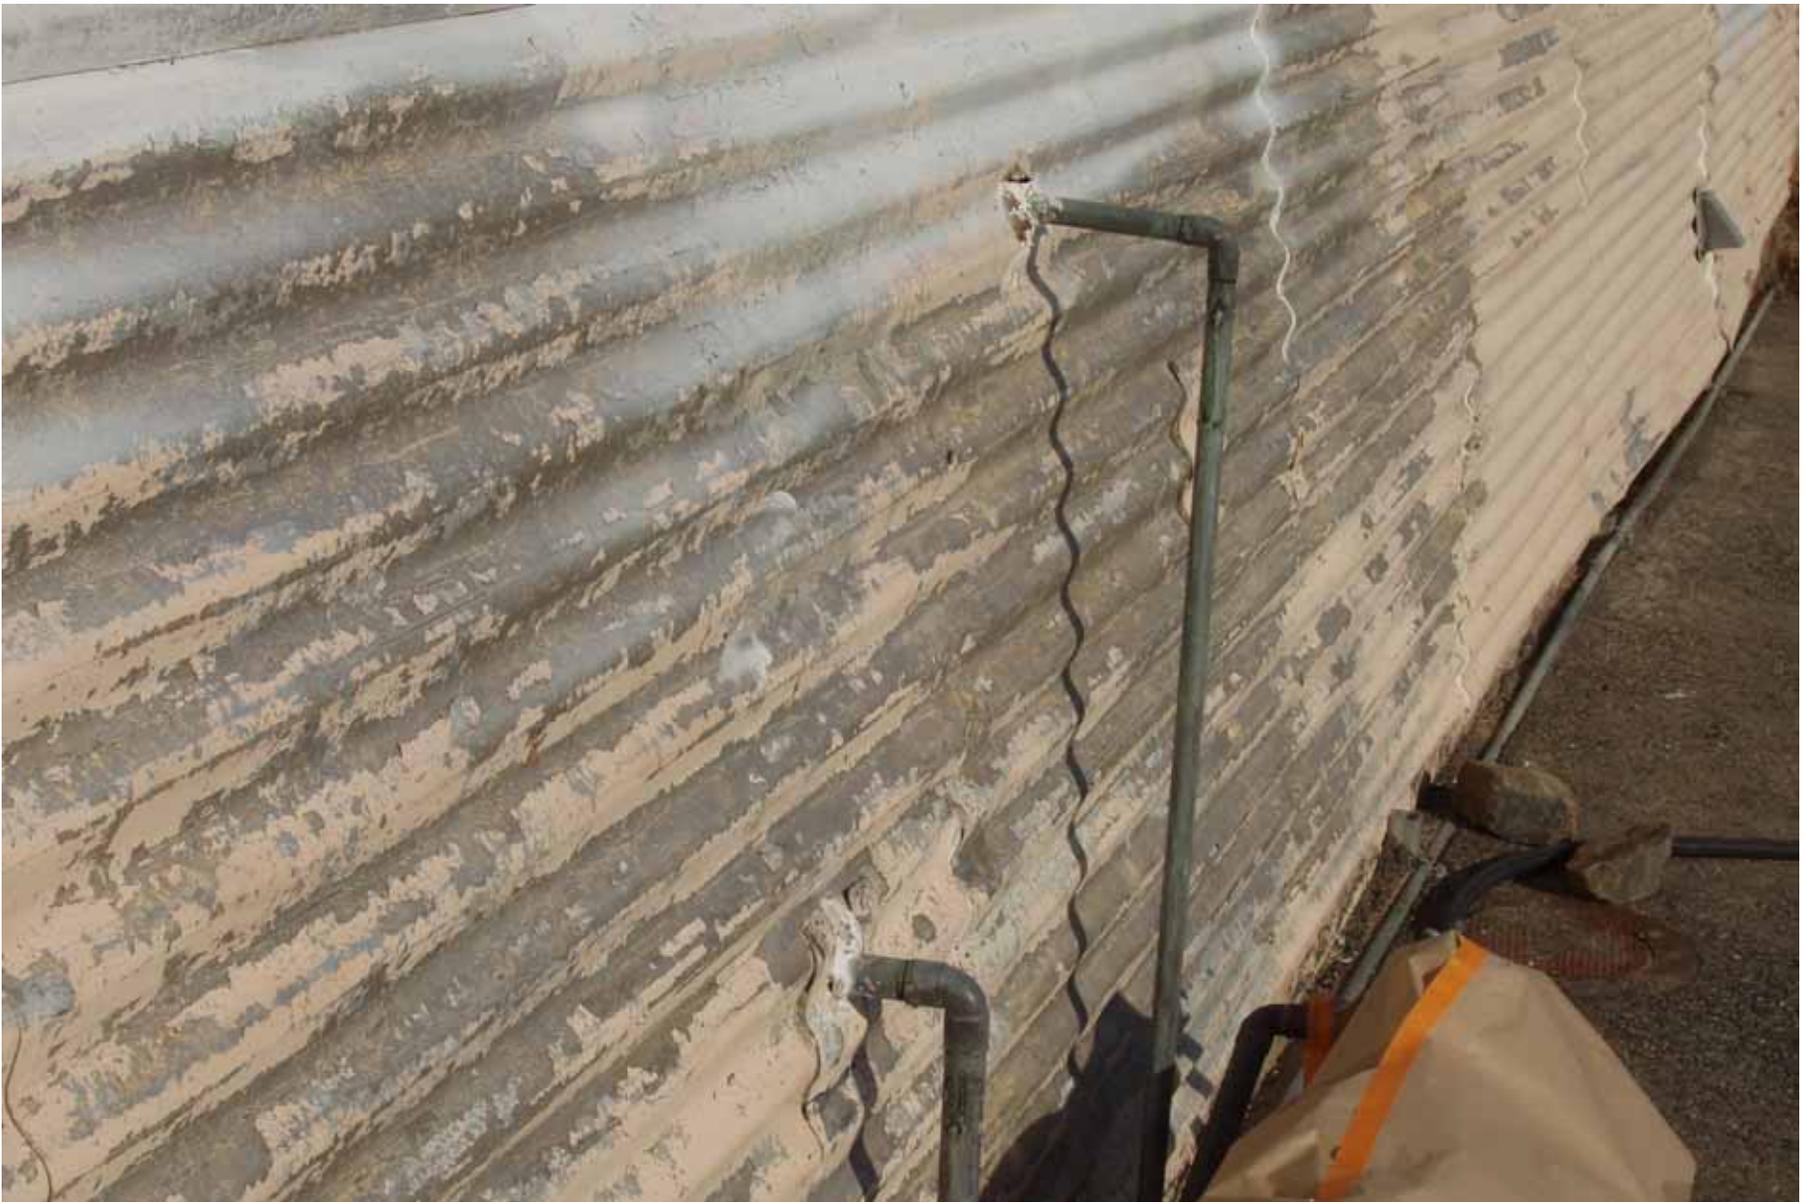
Paint preparation included caulking building penetrations and uneven seams

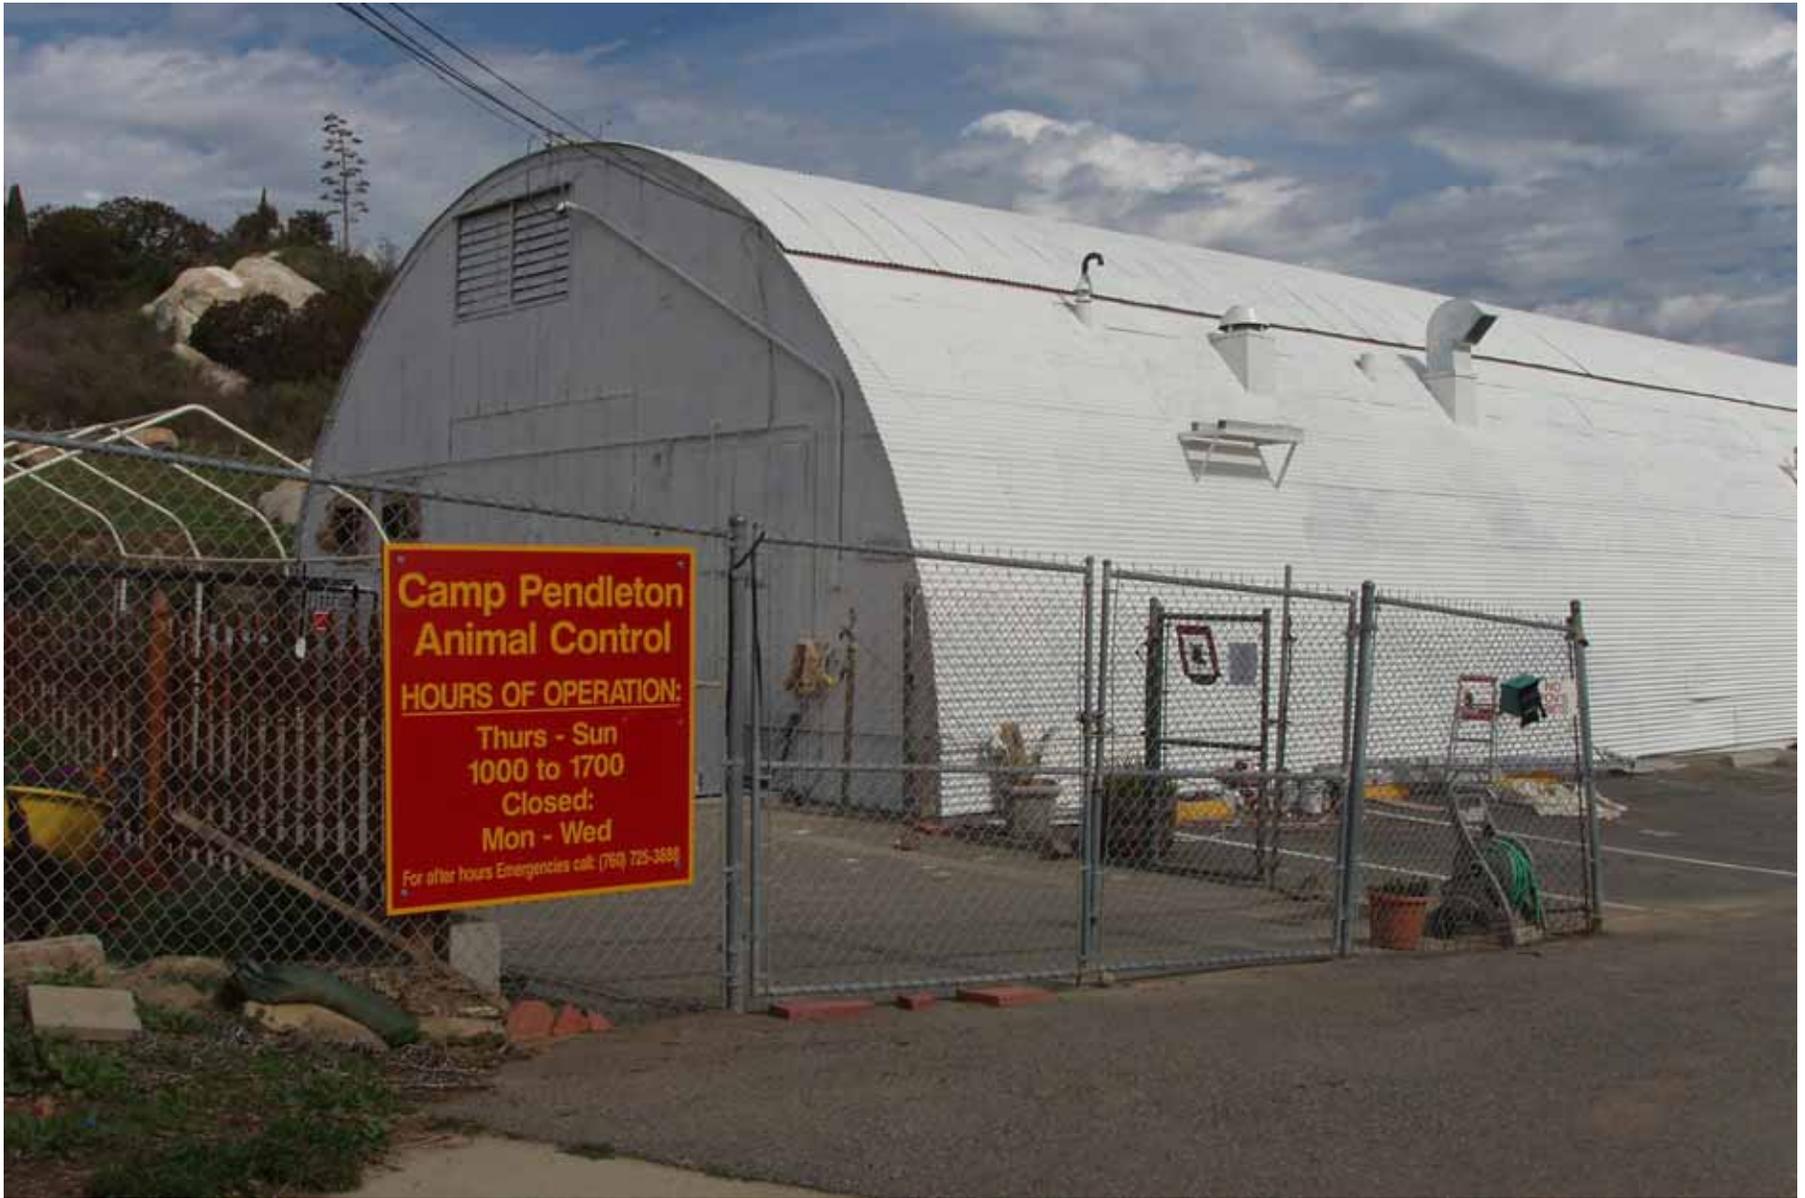
Entire building  
was primed

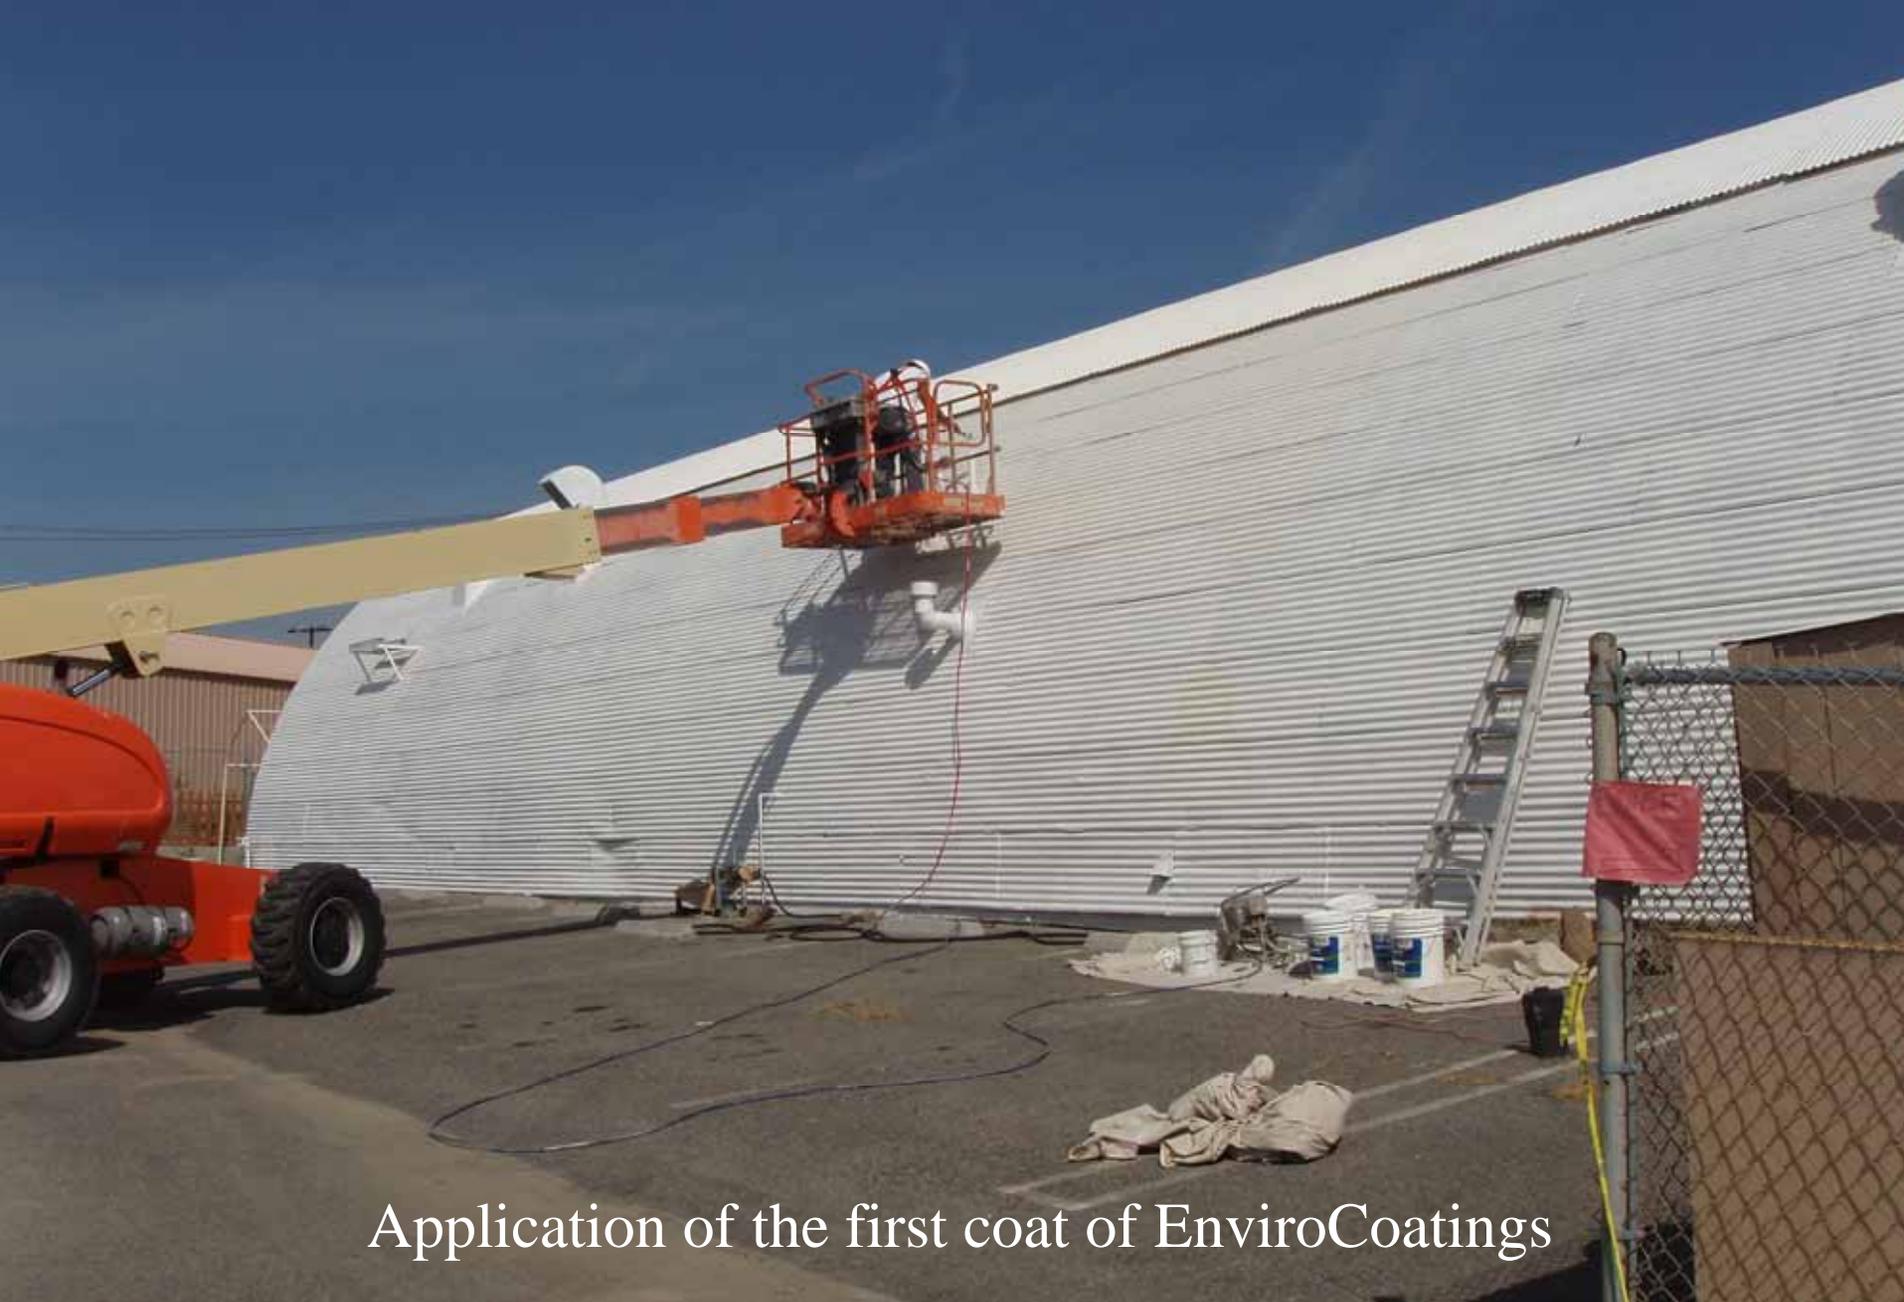
Application of the first coat of EnviroCoatings

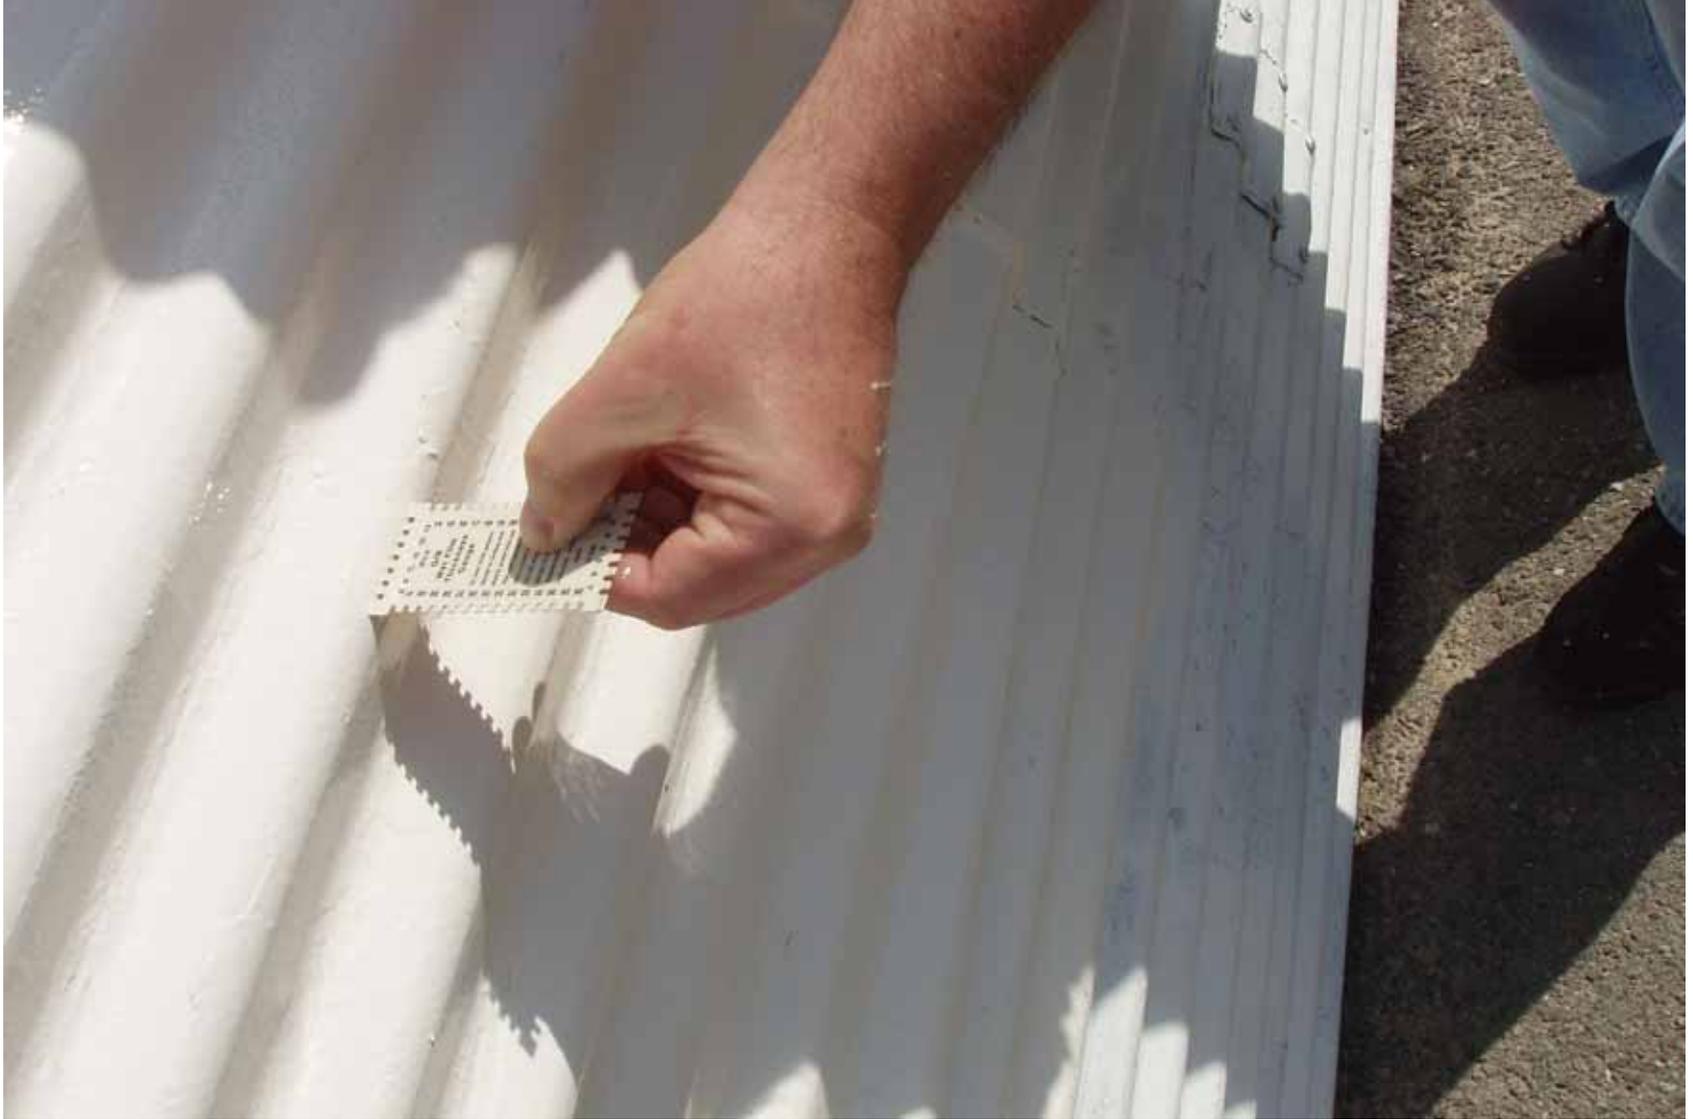
Wet Mil Gauge used to measure the applied coating thickness

EnviroCoatings Ceramic InsulCoat Exterior Wall specifications call for 8 - 10 wet mils per coat

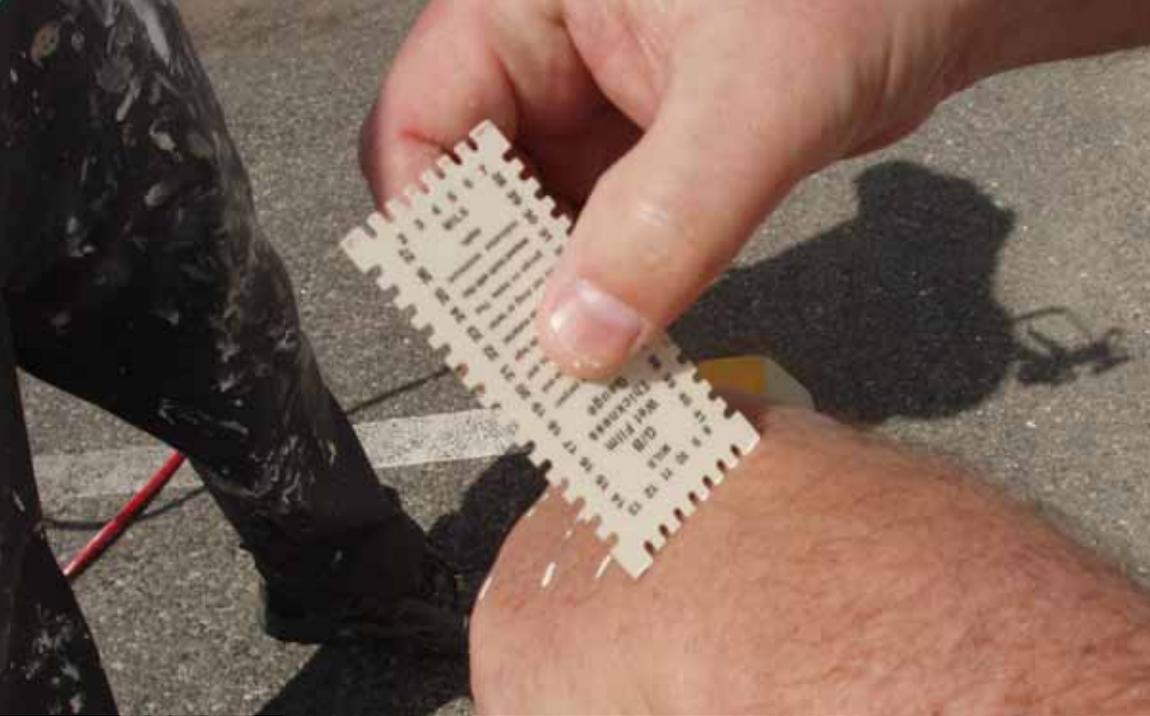
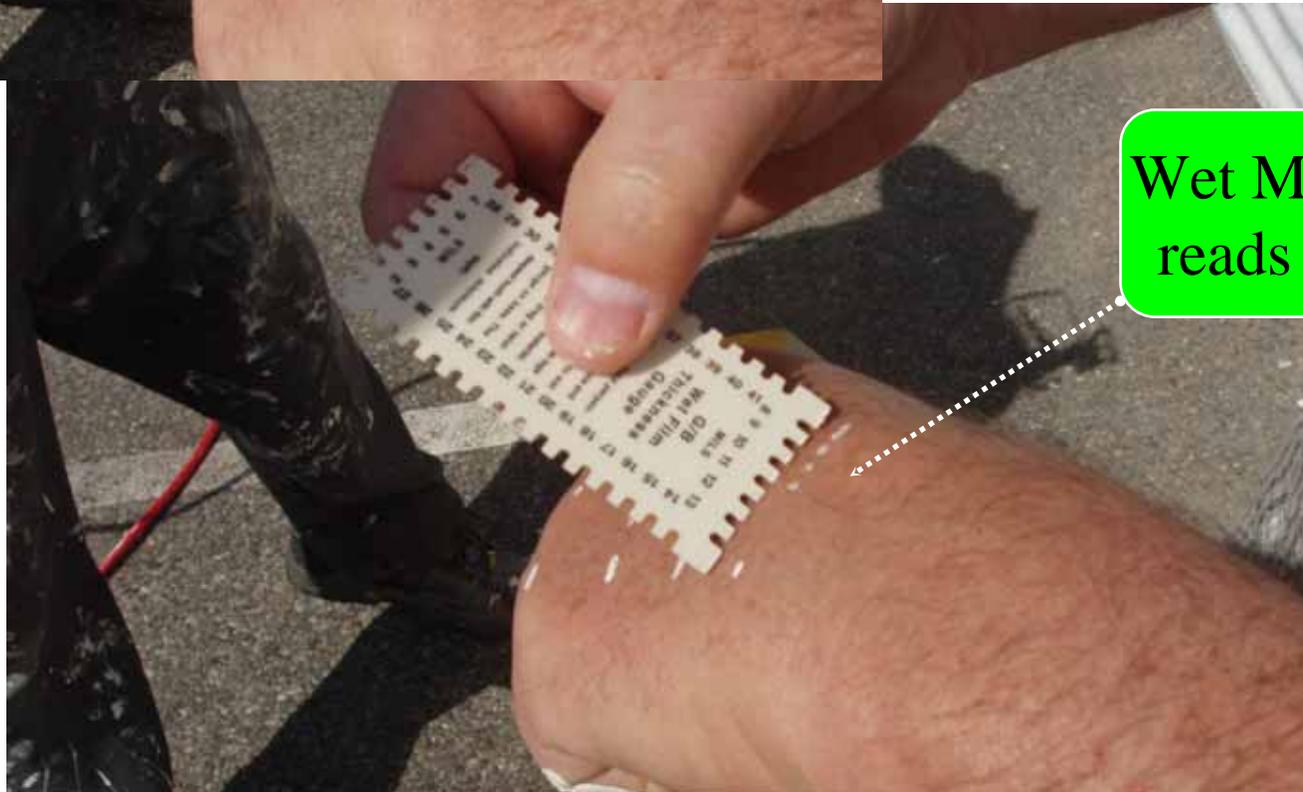
Wet Mil Gauge reads 10 mils

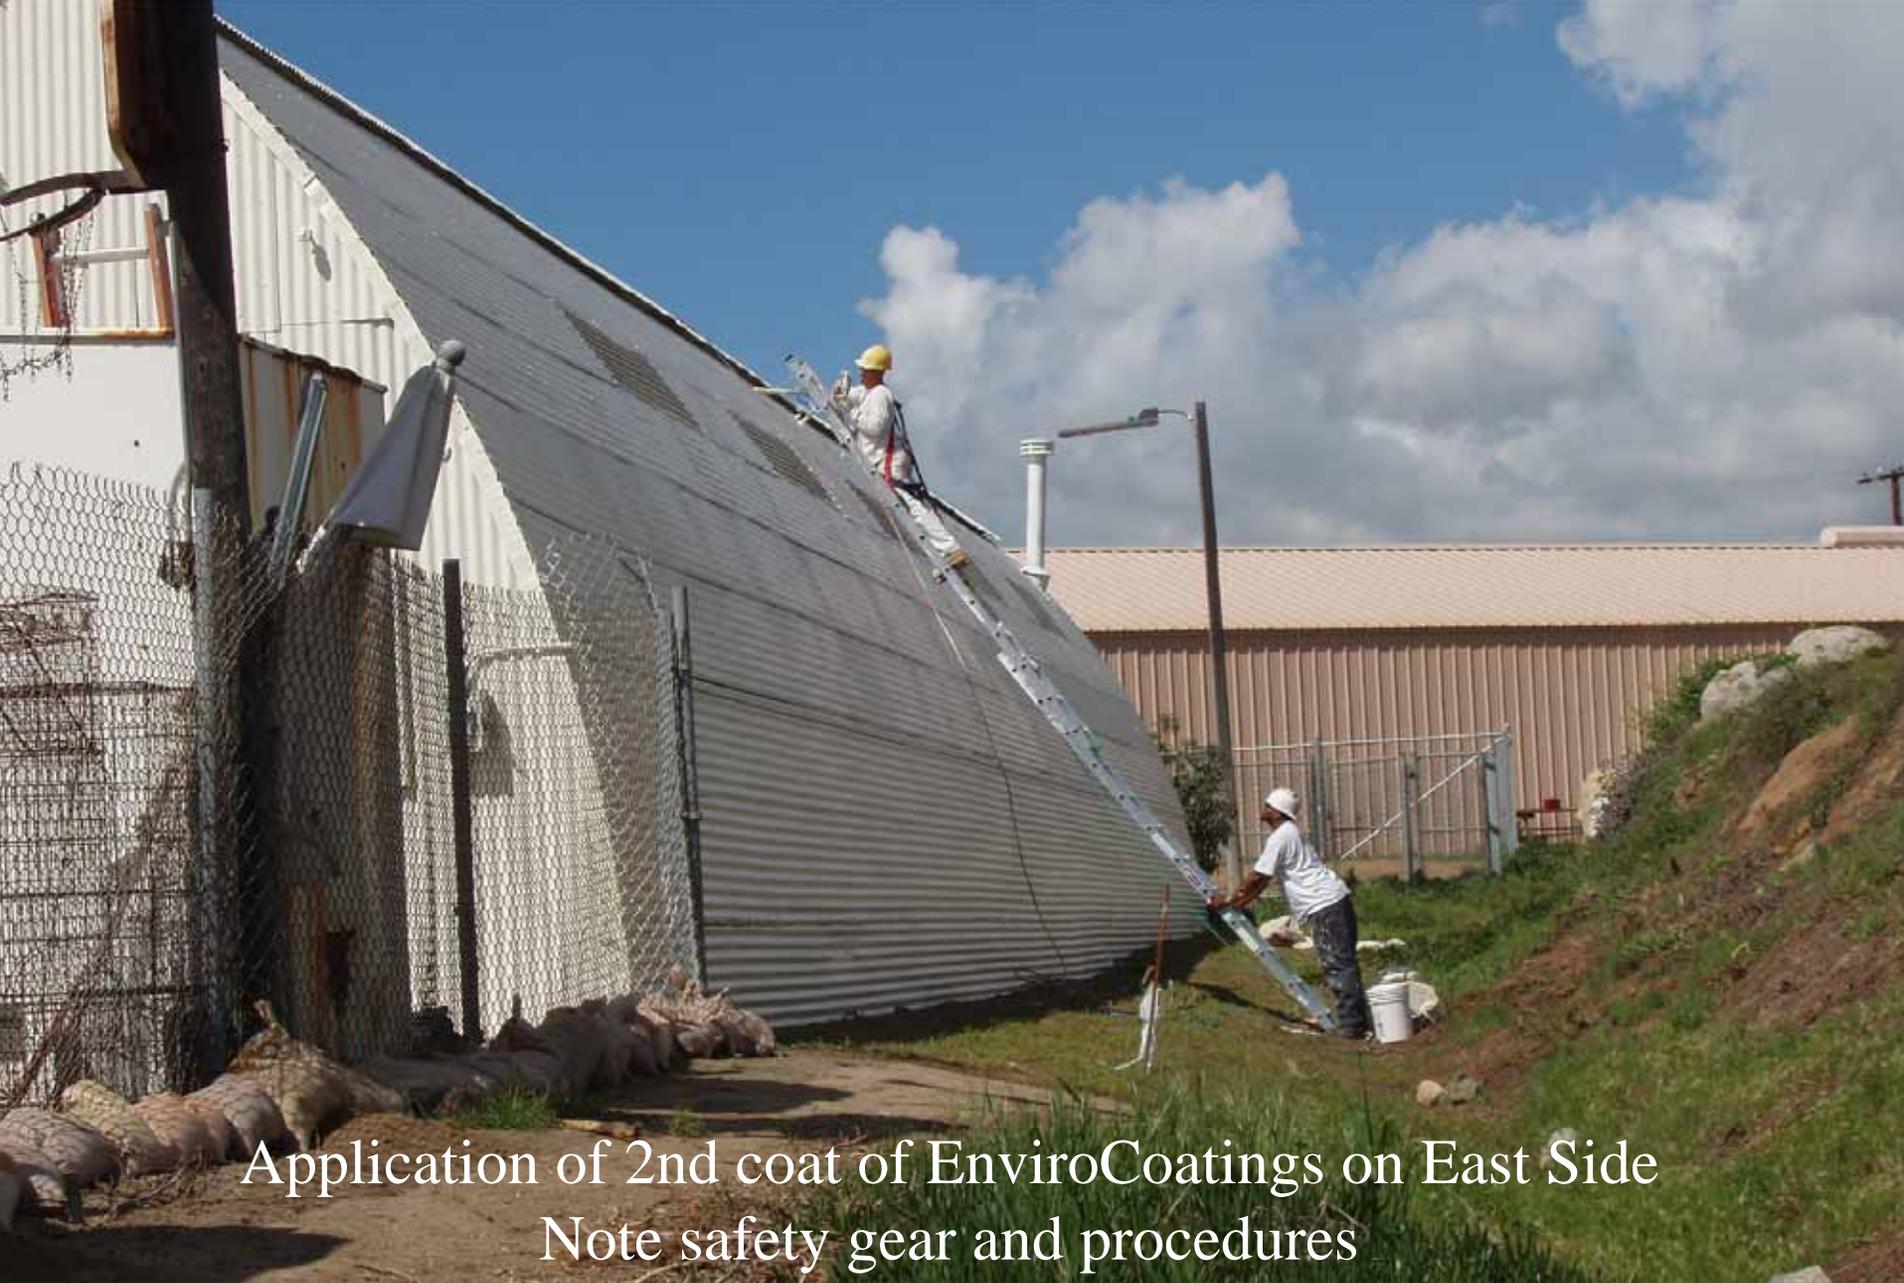
Application of 2nd coat of EnviroCoatings on East Side  
Note safety gear and procedures

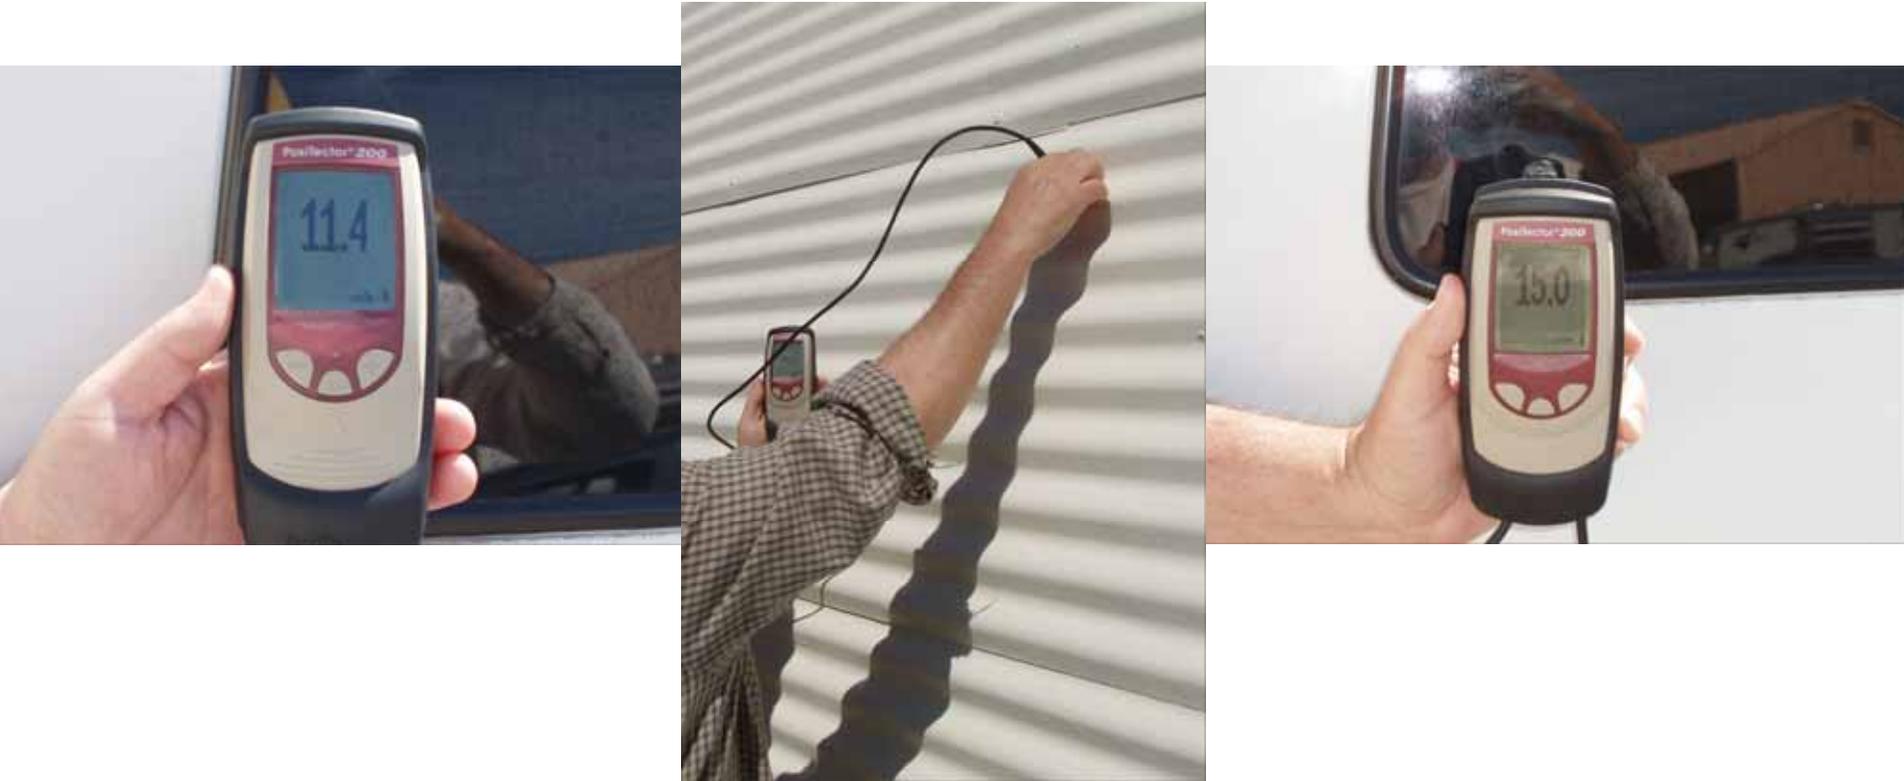
A series of Ultra-Sonic readings were taken around the Quonset Hut to measure dry film thickness. They confirmed EnviroCoatings Ceramic InsulCoat Exterior Wall was applied to specifications.

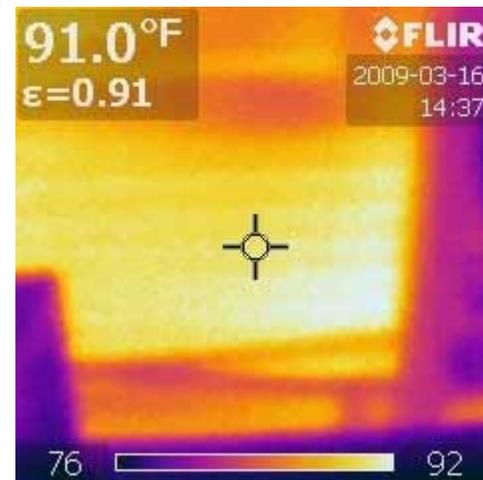
Comparing Interior Temperature of area that has a panel that was primed only with Metal Primer against the rest of the exterior wall coated with EnviroCoatings

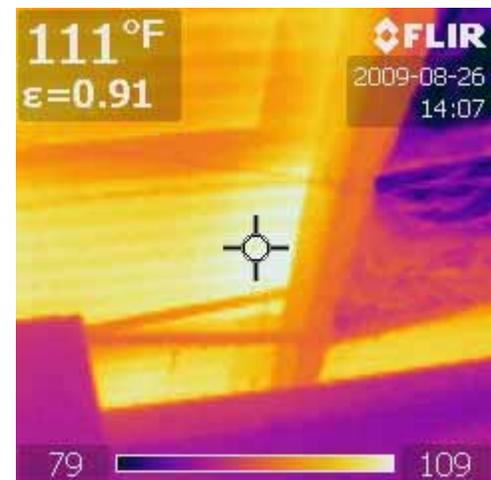
Comparing Interior Temperature of area that has a panel that was primed only with Metal Primer against the rest of the exterior wall coated with EnviroCoatings

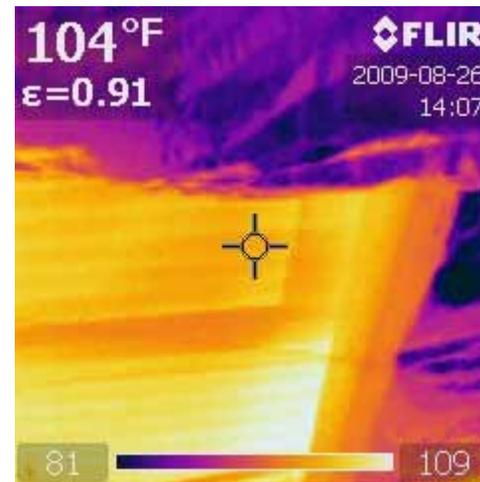
Lower panel in photo was painted only with Metal Primer

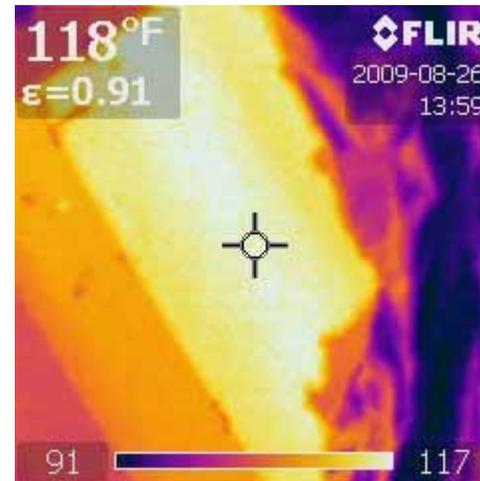
(Maximum temperature is 118°F)

3. Interior Crown surface temperatures decreased  
 $\langle 8^{\circ}\text{F} \rangle \approx \langle 6\% \rangle \downarrow$
