## **CASE STUDY: HEAT LOAD REDUCTION**

**Marine Corps Base Camp Pendleton, California**

**Vado Del Rio Area 25**

**Animal Control Facility**

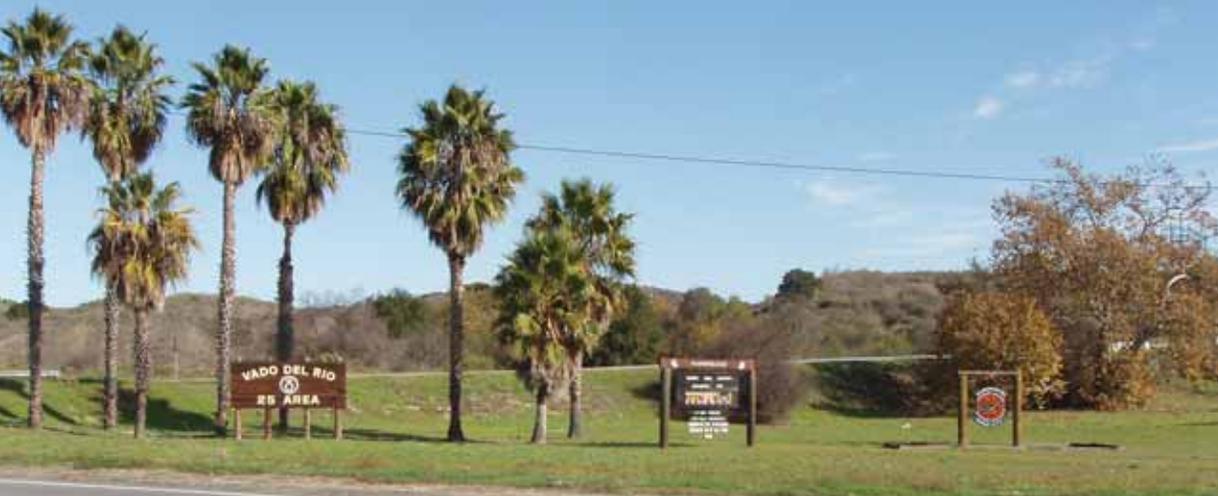
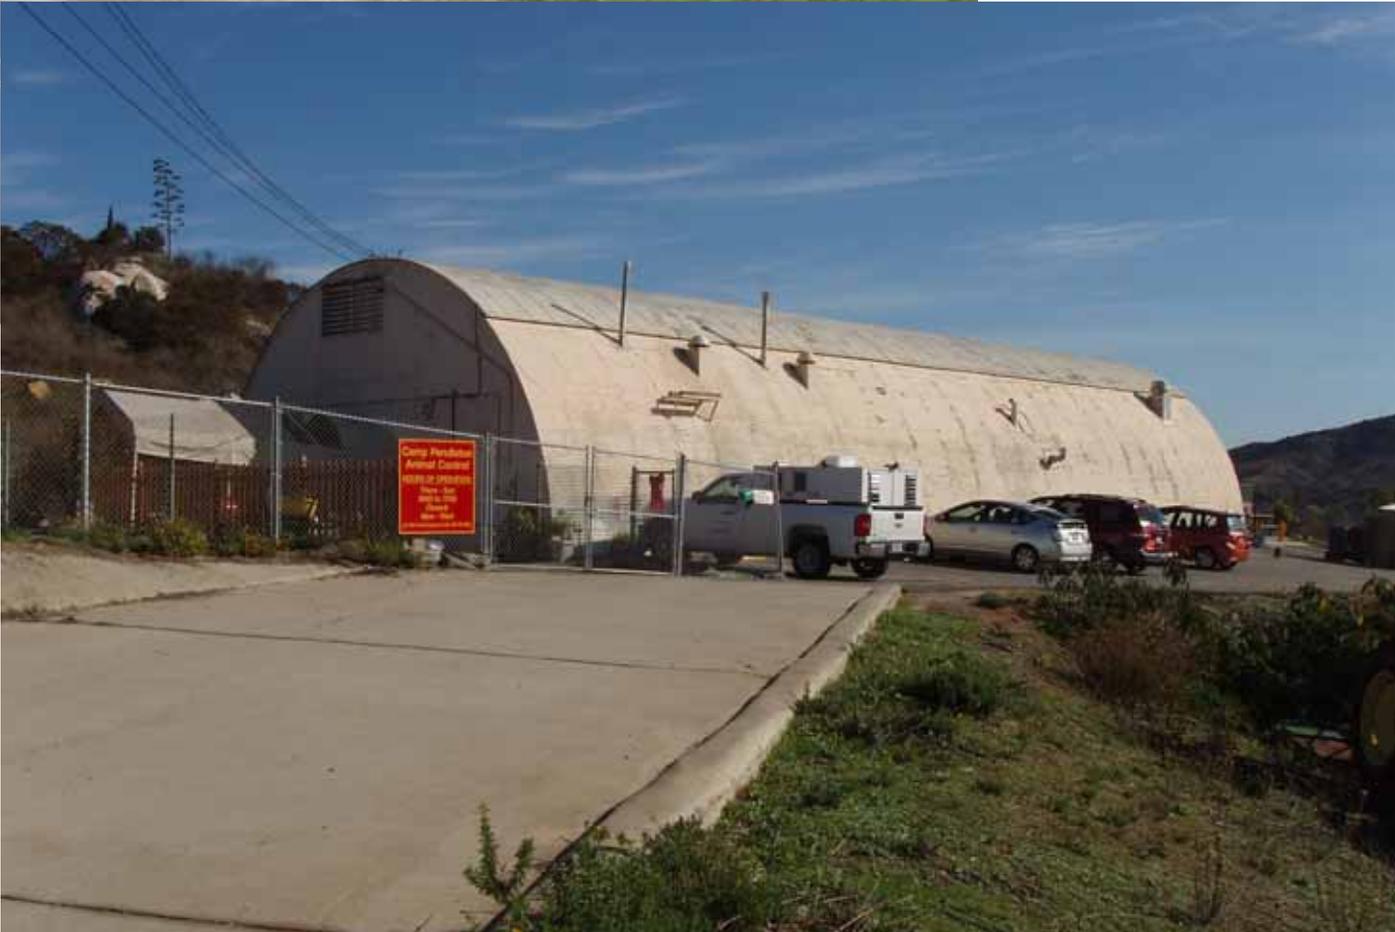
## Summer 2008

The Quonset Hut had been painted on numerous occasions over the years.

The exterior membrane had degraded and chipped/peeled off the structure exposing the various layers of paint buildup and bare metal.

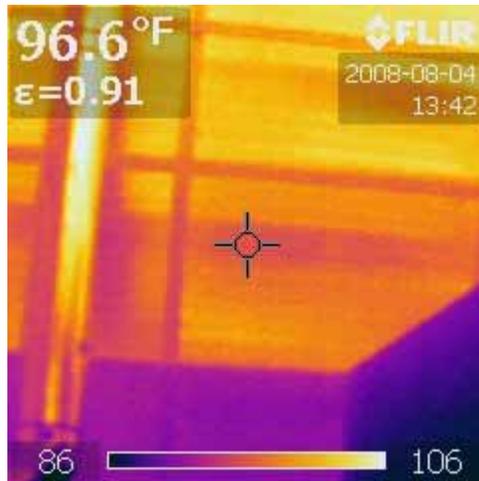
Low wall above animal pens

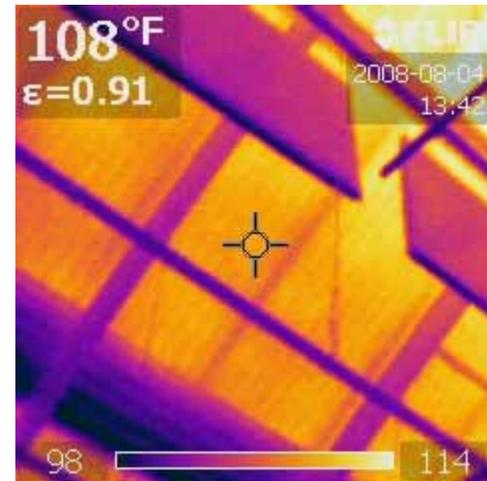
High wall near crown of building

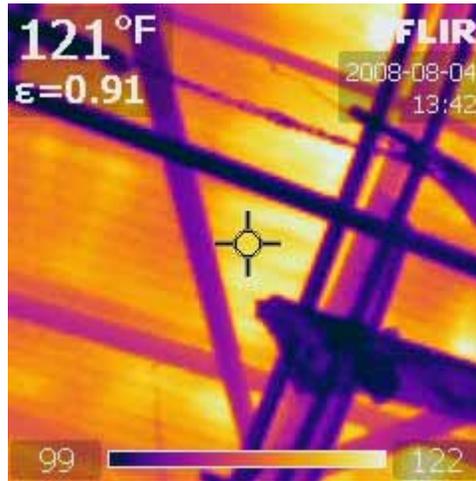
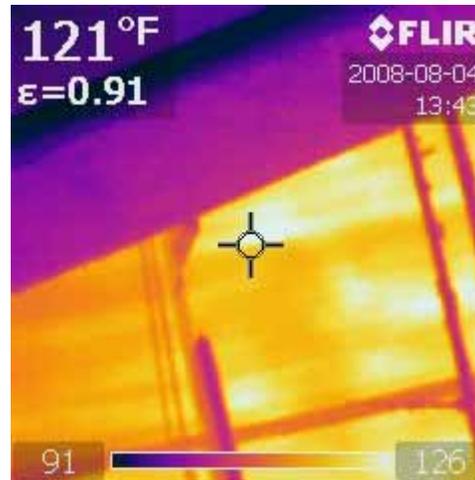
# Infrared Photos of the Interior Crown

Greatest heat load on the building recorded here. 126° F maximum recorded temperature (Note temperature range on each photograph).

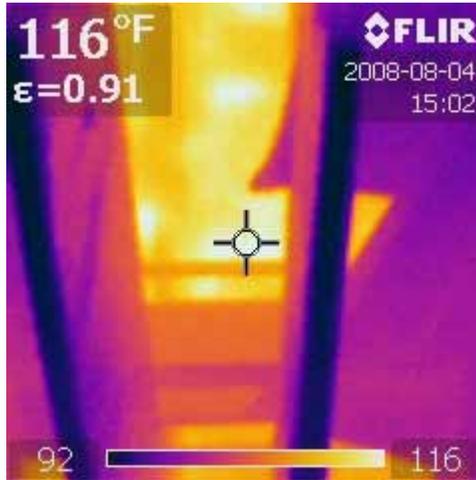
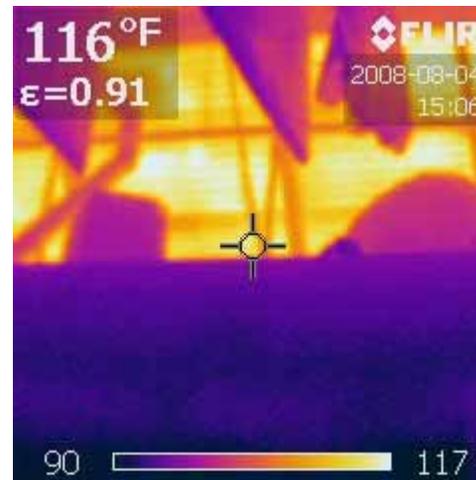
# Infrared Photos of the West Side Interior at 3PM

No significant increase of interior temperatures when compared to earlier photos taken at 1:40 PM.

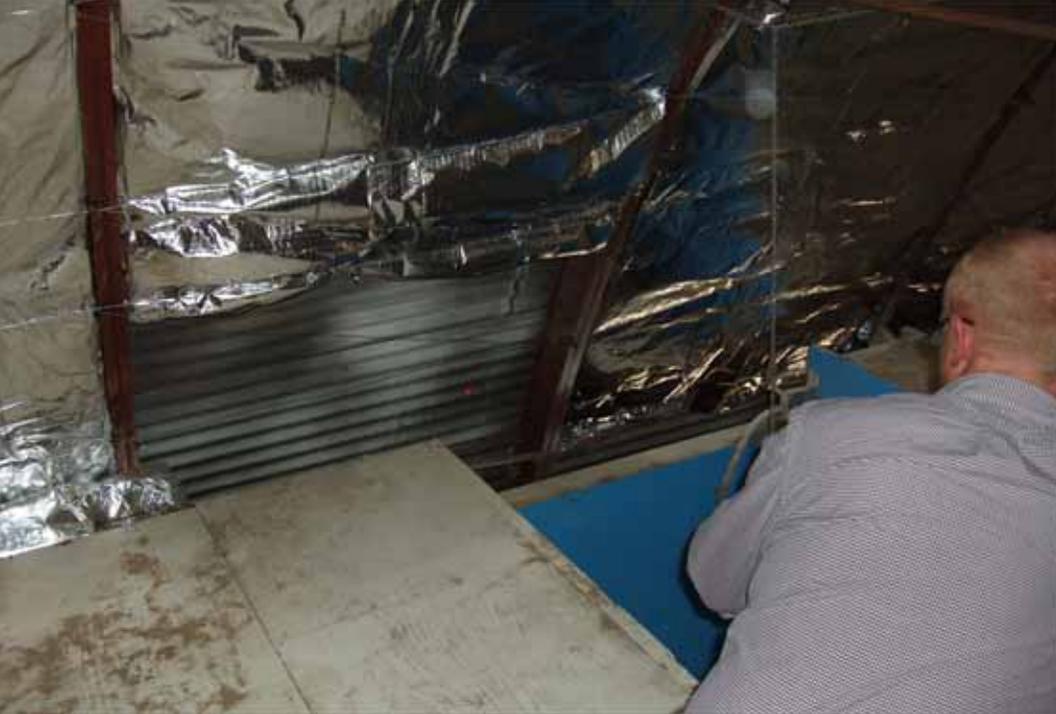
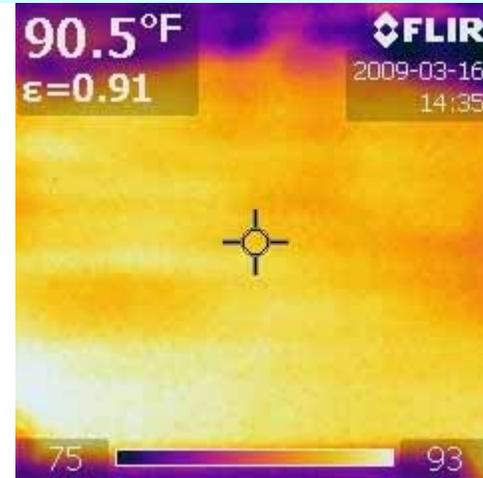
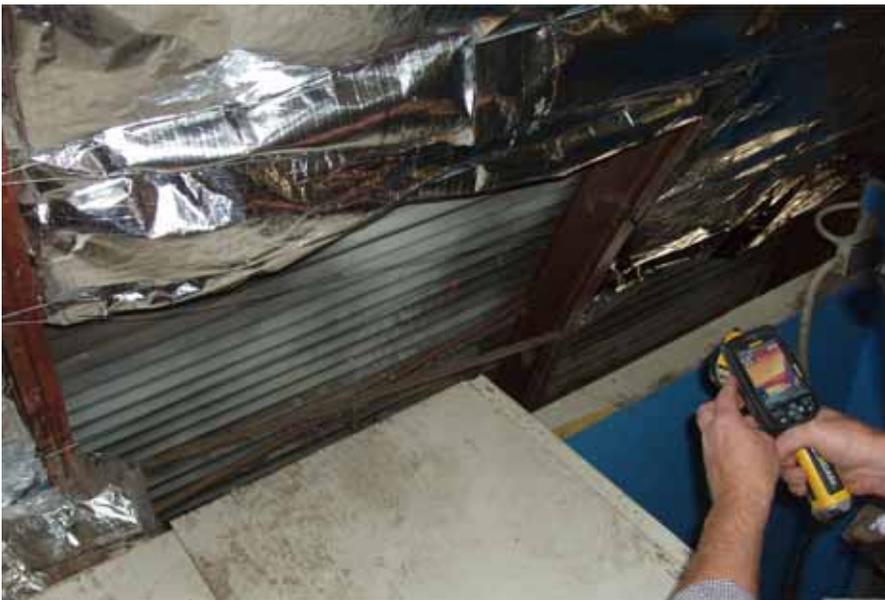
# Infrared Photos of the West Side Interior

Comparing Interior Temperature of area that has a panel that was primed only with Metal Primer against the rest of the exterior wall coated with EnviroCoatings

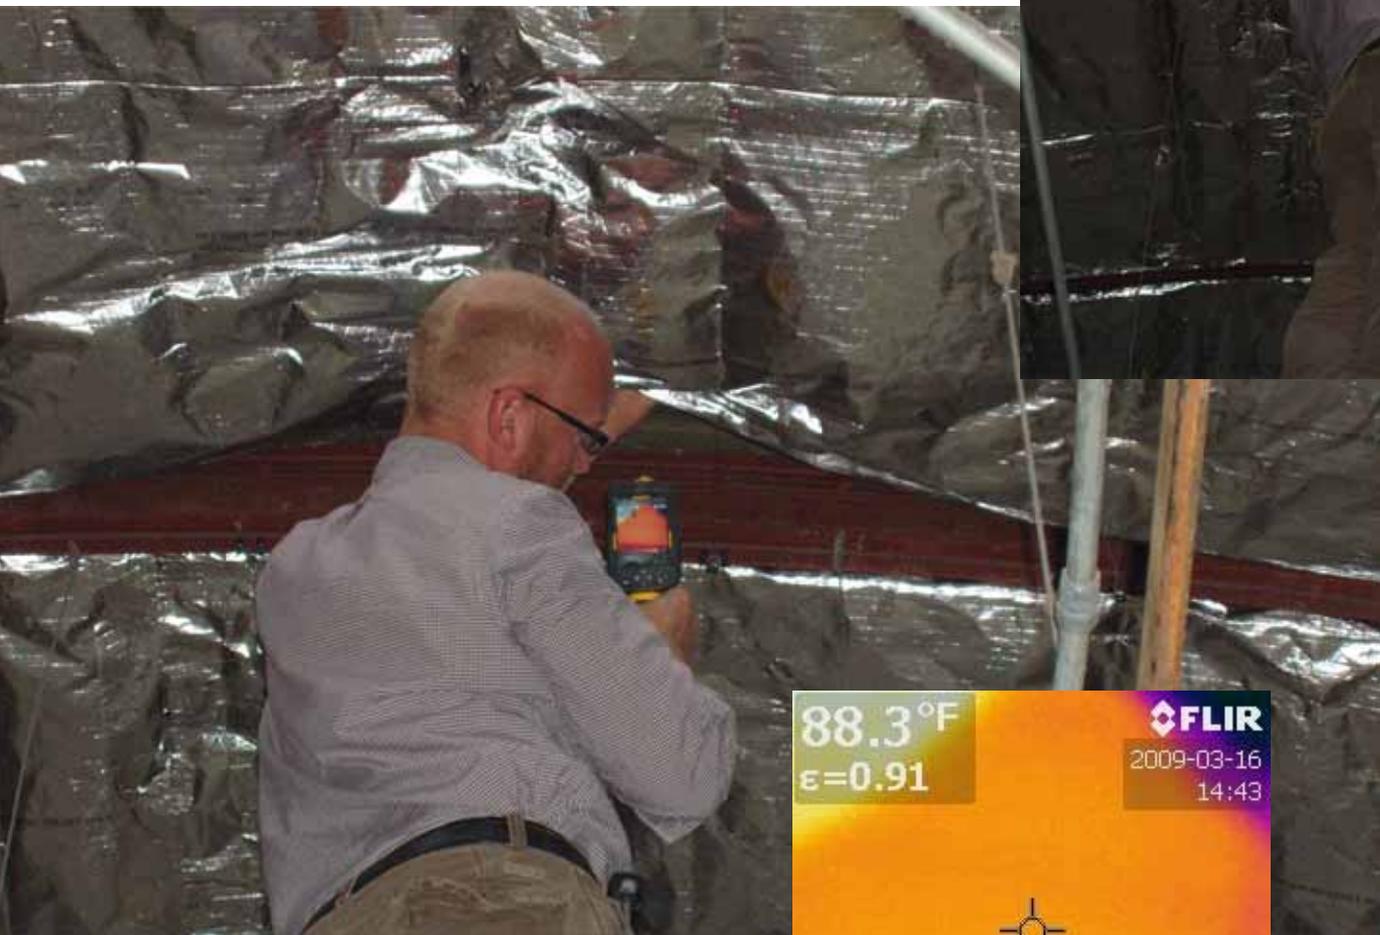
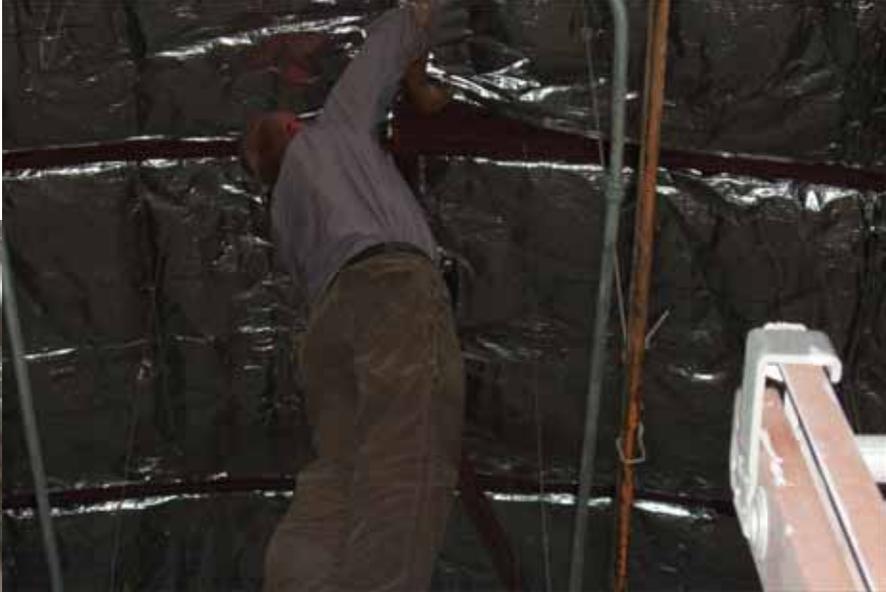
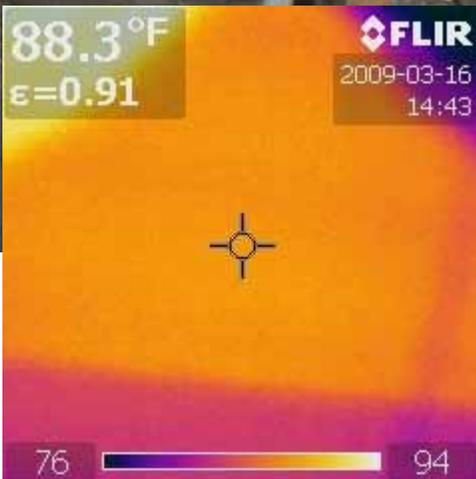
# Infrared Photos of the Interior Crown

Above the door  
to the Animal  
Quarantine Area

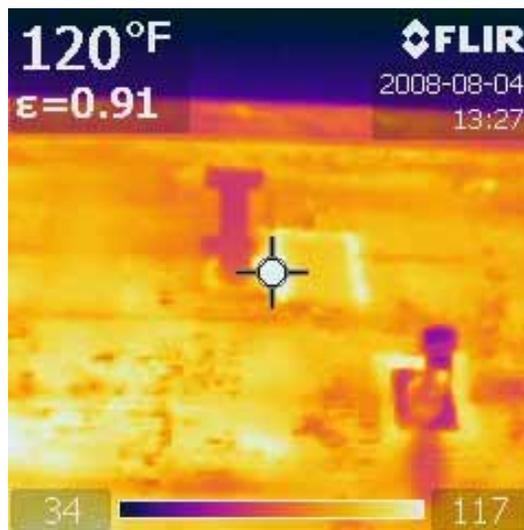
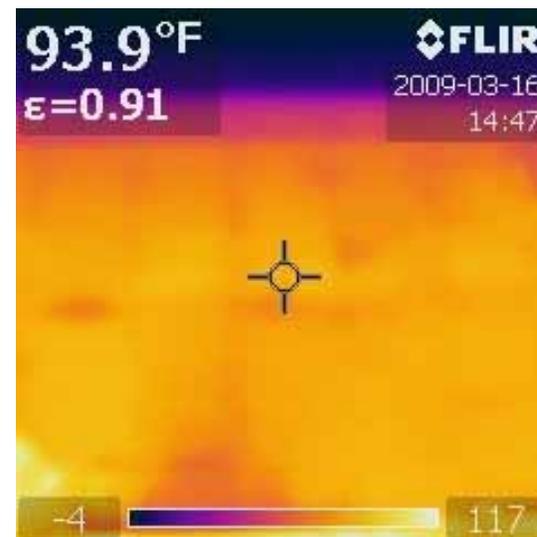
# Comparisons - West Side Exterior

- August 4, 2008
- Bright, Sunny sky
- 84°F ambient air temperature
- March 16, 2009
- Bright, Sunny sky
- 68°F ambient air temperature

1. Exterior surface temperatures have decreased 17% - 22% ↓
2. Interior surface temperatures have decreased 22% - 27% ↓

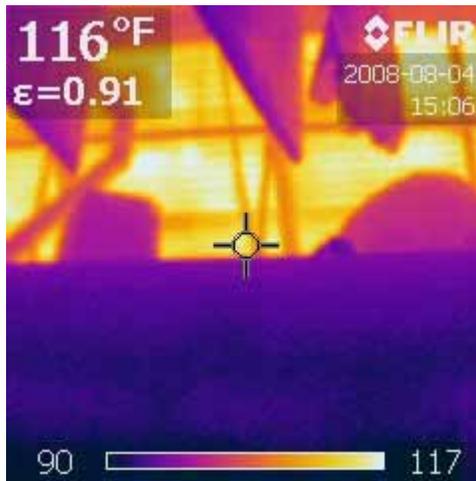
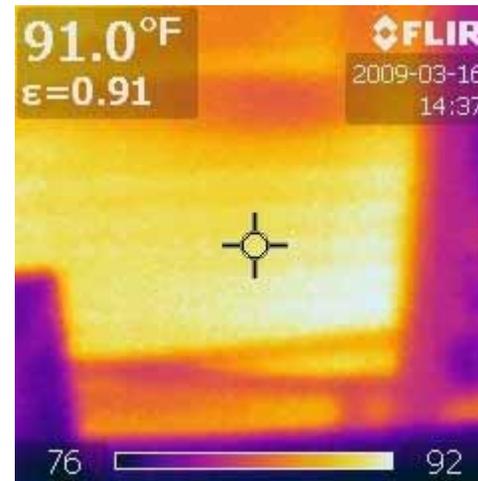
# Comparisons - West Side Interior

- August 4, 2008
- Bright, Sunny sky
- 84°F ambient air temperature
- March 16, 2009
- Bright, Sunny sky
- 68°F ambient air temperature

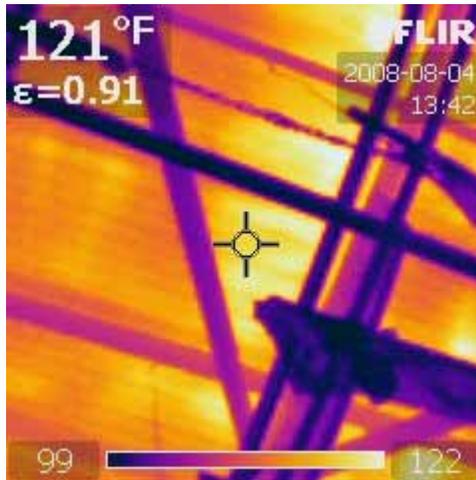
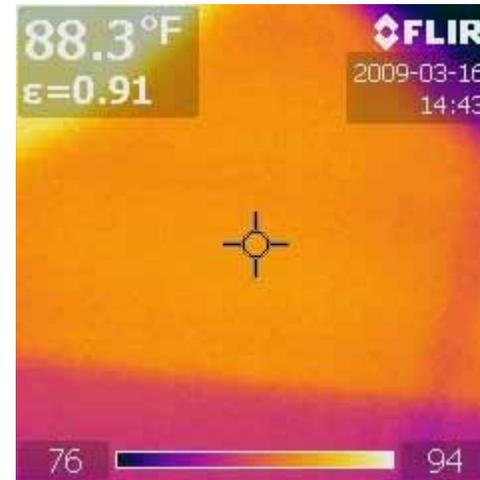
# Comparisons - Interior Crown

- August 4, 2008
- Bright, Sunny sky
- 84°F ambient air temperature
- March 16, 2009
- Bright, Sunny sky
- 68°F ambient air temperature

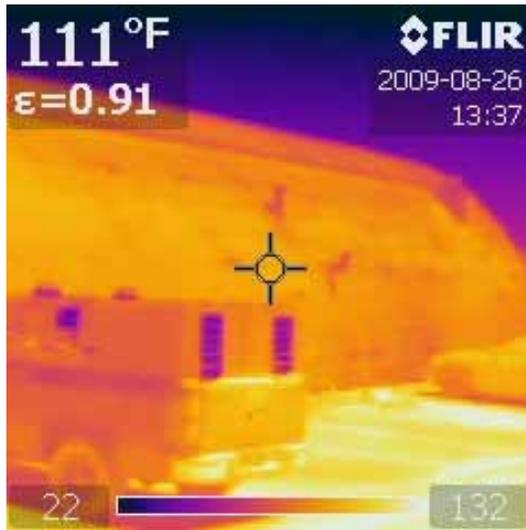
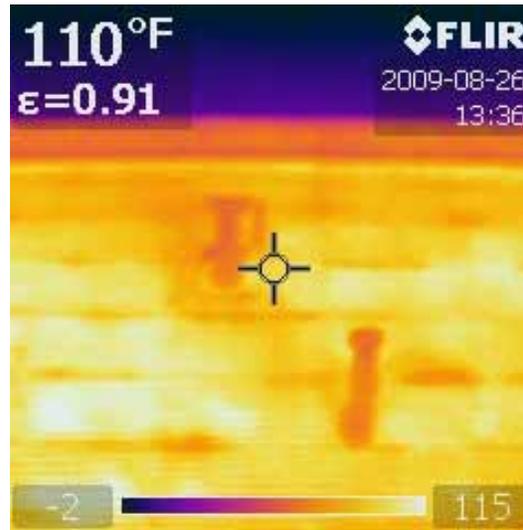
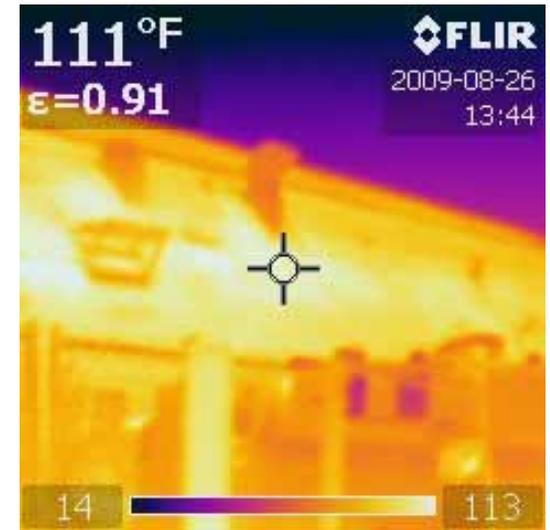
# Infrared Photos of the West Side Exterior

Attempted to have similar photographs as those that were taken on August 4, 2008

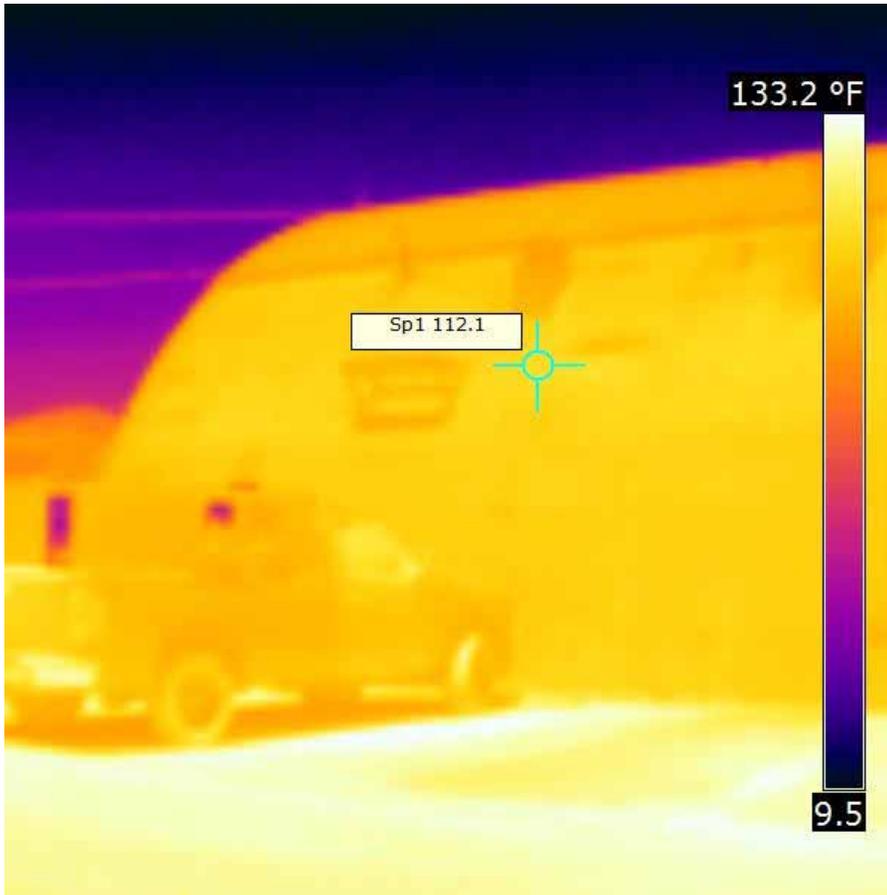
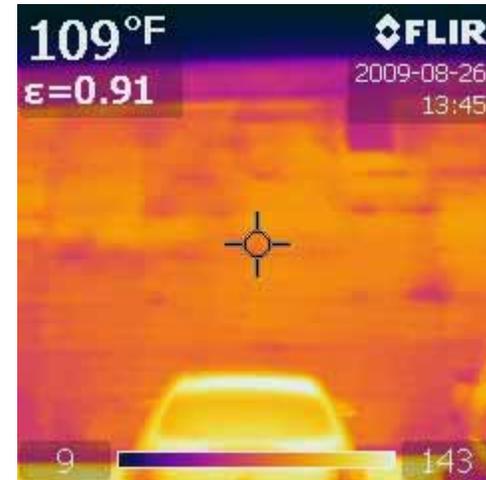
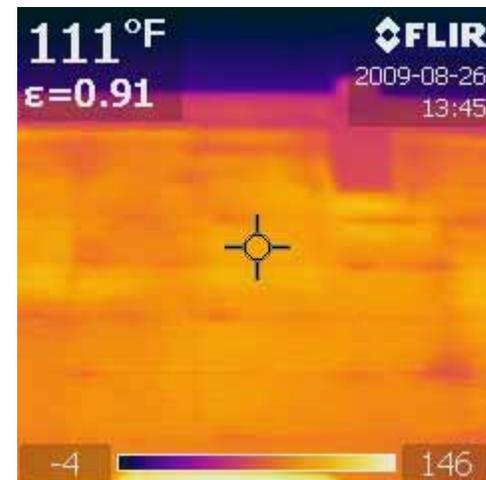
# Infrared Photos of the West Side Exterior

Note the surface temperature of the roof and trunk of the parked car.

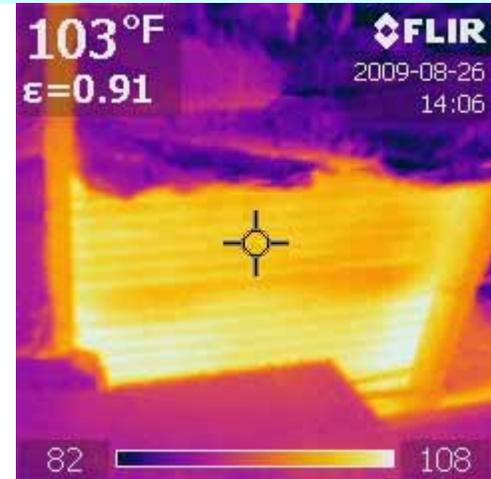
# Infrared Photos of the West Side Interior

Comparing Interior Temperature of area that has a panel that was primed only with Metal Primer against the rest of the exterior wall coated with EnviroCoatings

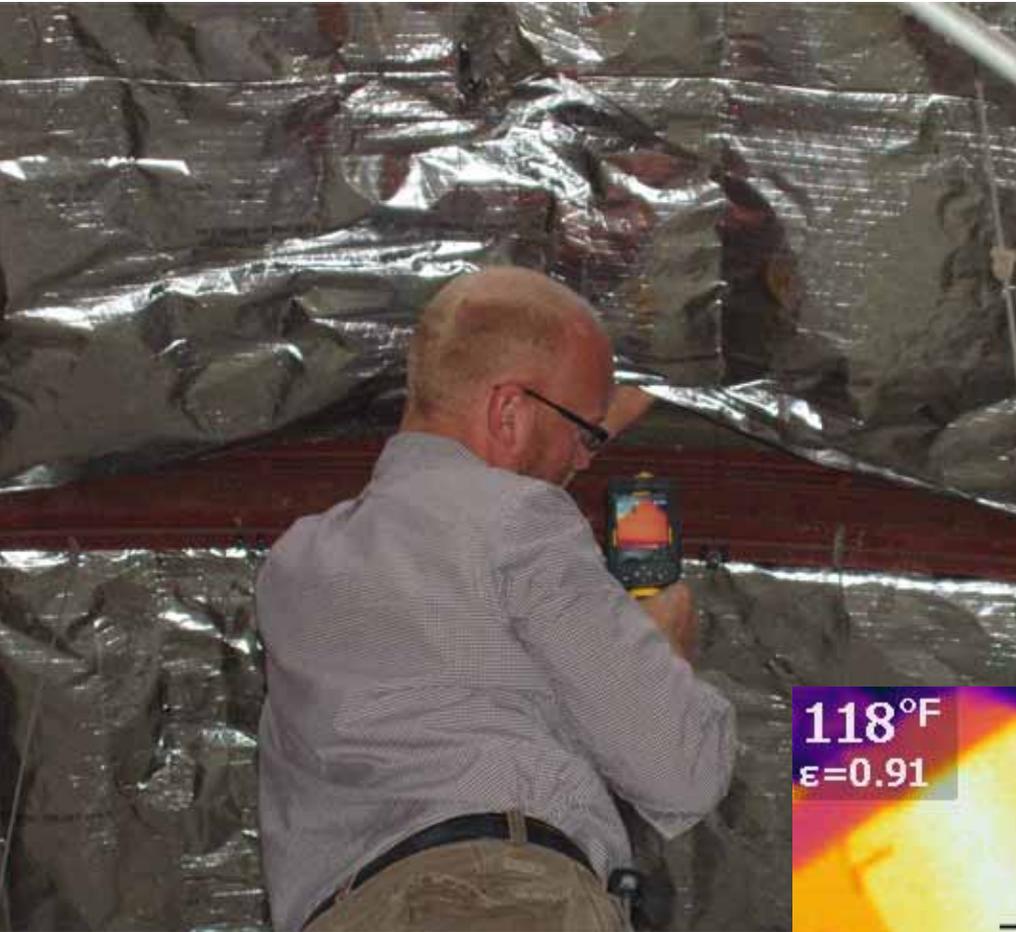
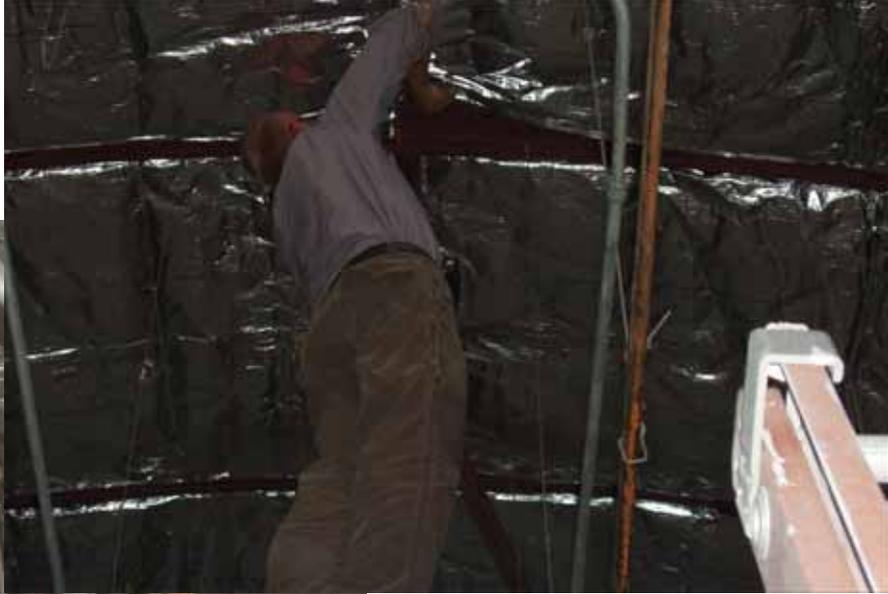
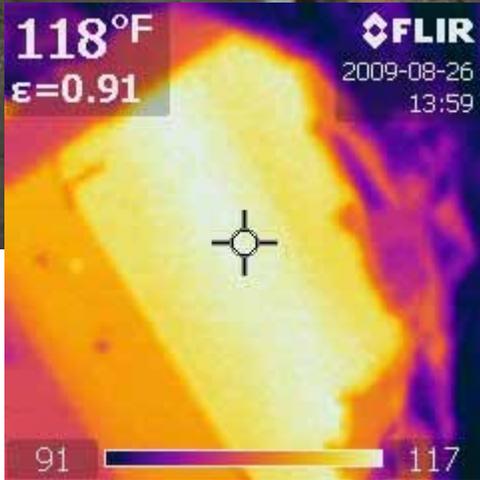
# Infrared Photos of the Interior Crown

Above the door  
to the Animal  
Quarantine Area

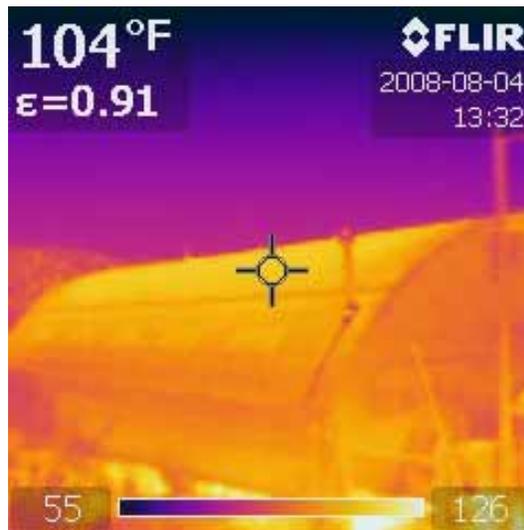
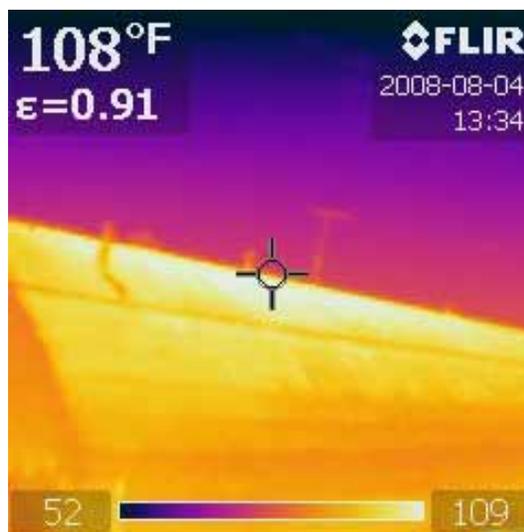
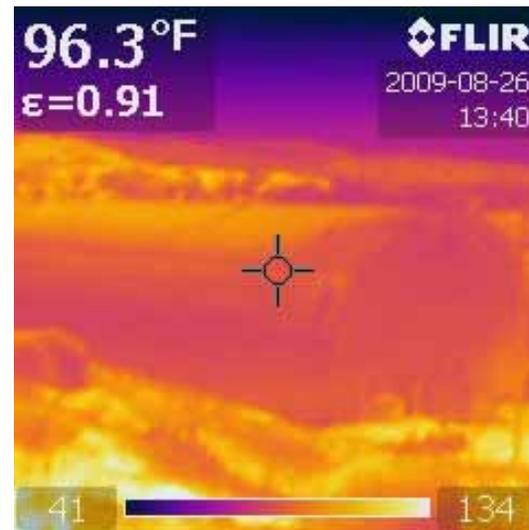
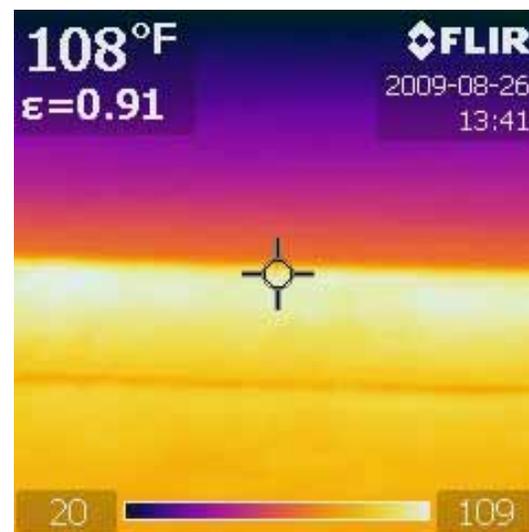
# Comparisons - East Side Exterior

2. Exterior surface temperatures decreased from  
 $0^{\circ}\text{F}$  to  $\langle 5^{\circ}\text{F} \rangle \approx 0\%$  to  $\langle 4\% \rangle \downarrow$

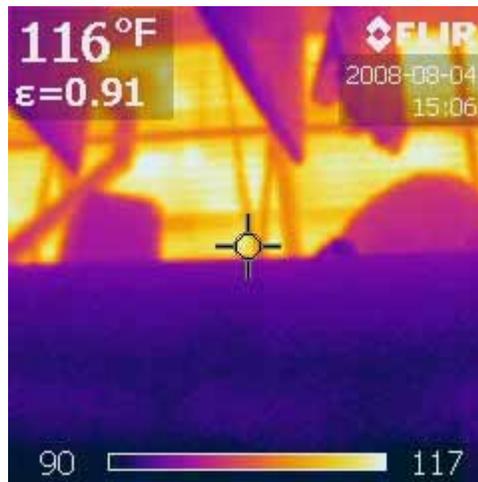
# Comparisons - West Side Interior

Lower panel in photo was painted only with Metal Primer

4. Interior West Wall surface temperatures decreased  
 $\langle 12^{\circ}\text{F} \rangle \approx \langle 10\% \rangle \downarrow$

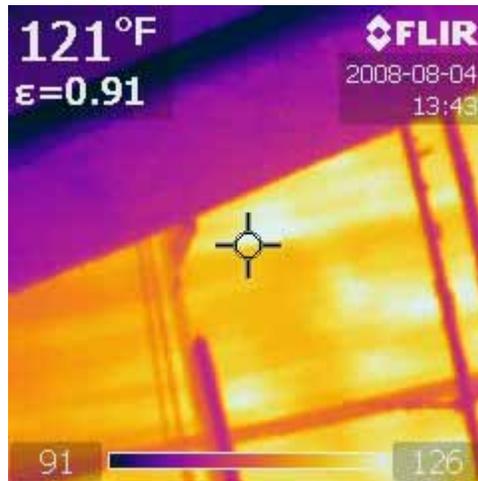
# Comparisons - Interior Crown

(Maximum temperature is 126°F)

3. Interior Crown surface temperatures decreased  
 $\langle 8^{\circ}\text{F} \rangle \approx \langle 6\% \rangle \downarrow$
